Failure to Create Circuit Between CE Card on ONS 15310 and ML Card on ONS 15454

Document ID: 69337

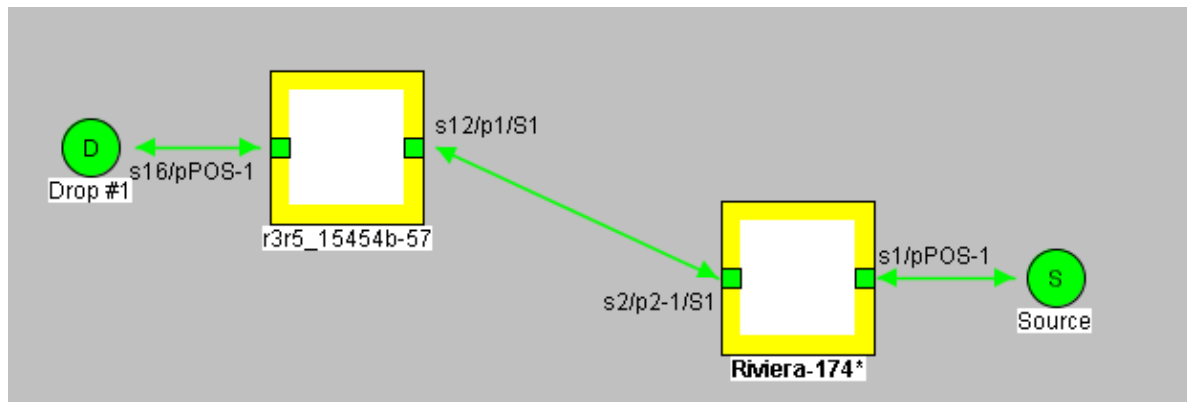
Figure 4: Circuit Detailed Map

If both ports are configured with the same encapsulation using HDLC or LEX, the circuit successfully comes up (see Figure 4).
