1 GHz GainMaker System Amplifier Low Forward Band Roll-off Technical Bulletin

Overview

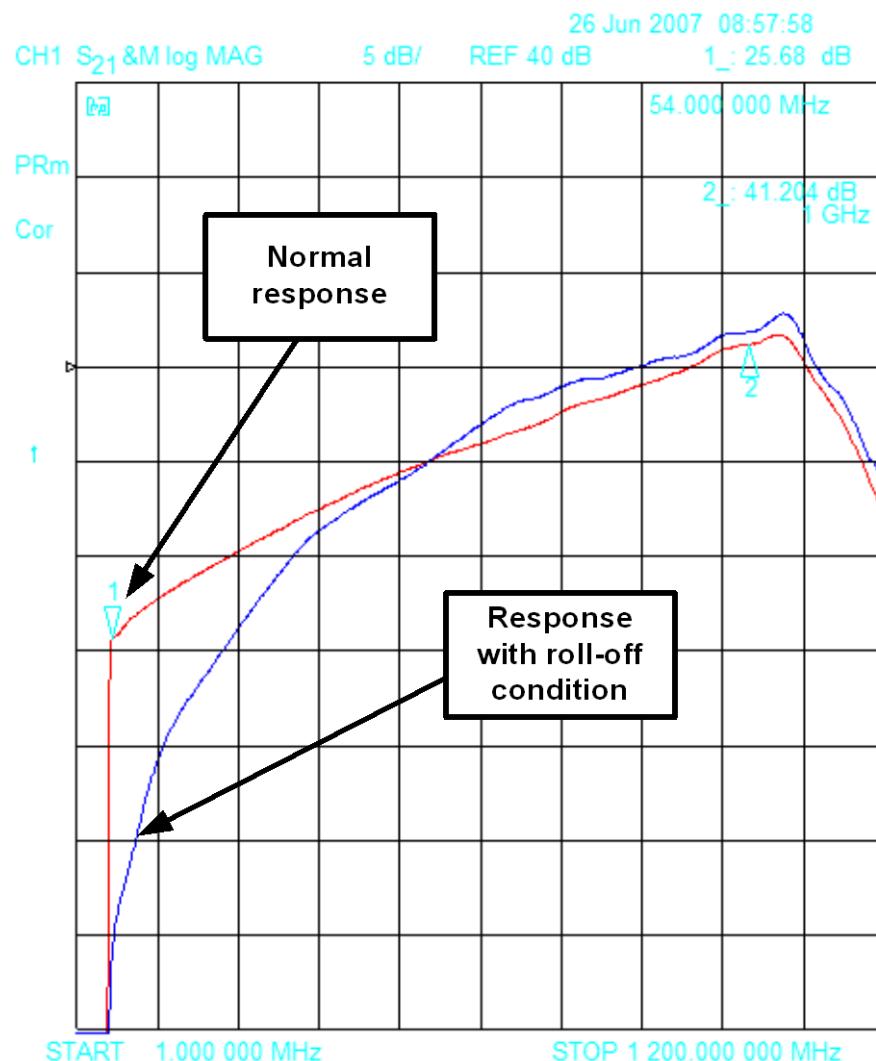
An issue was discovered recently with 1 GHz GainMaker® System Amplifiers exhibiting signal roll-off in the lower portion of the forward frequency band. The roll-off occurs when one or more capacitors in the pre-amplifier section become fractured. The effect of the damaged capacitor(s) on performance is most significant and noticeable in the lower portion (channels 2-6) of the forward band.

Reduced gain in the forward band, particularly at low frequencies, is a symptom of a possible fractured-capacitor condition. In the figure below, the plot labeled **Normal response** shows typical amplifier or node gain at 54 MHz. The plot labeled **Response with roll-off condition** shows the greatly reduced gain at the lower end of the band.

Note: This plot shows a gain reduction of nearly 15 dB at 54 MHz, but as little as 5 dB gain reduction at 54 MHz may indicate a fractured-capacitor condition.

If an amplifier exhibits the trouble symptom described in this document, we recommend returning the unit to Cisco for repair or replacement. Refer to *For Information* (on page 5).
