Application Note

Portchannels with EMC SRDF/A

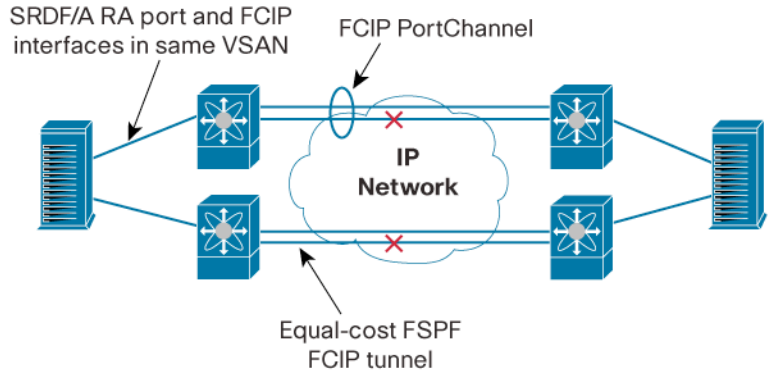
Figure 1. Scenario with One RA Port per Fabric

In this scenario (Figure 1), there is one RA port per fabric that traverses multiple FCIP tunnels. The upper half of the diagram shows two FCIP tunnels as part of a PortChannel. The lower half of the diagram shows the two FCIP tunnels with equal FSPF costs. The problem as described by the EMC knowledge base can occur if an FCIP tunnel in either path fails.

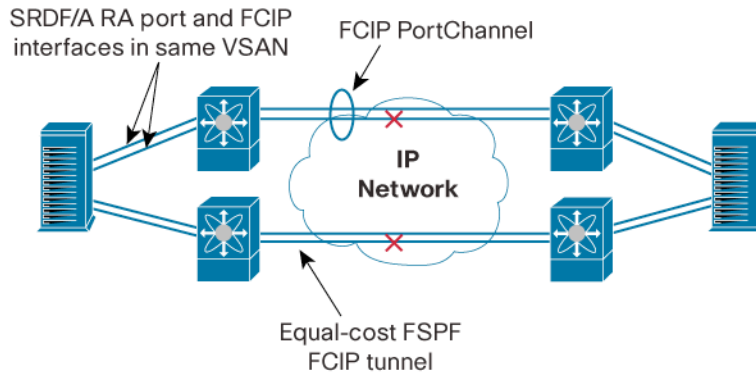
Figure 3. Scenario with Two RA Ports per Fabric

In this scenario (Figure 3), there are two RA ports per fabric that traverse multiple FCIP tunnels. The upper half of the diagram shows two FCIP tunnels as part of a PortChannel. The lower half of the diagram shows the two FCIP tunnels with equal FSPF costs. The problem as described by the EMC knowledge base can occur if a FCIP tunnel in either path fails
