1 GHz GainMaker System Amplifier Low Forward Band Roll-off Technical Bulletin

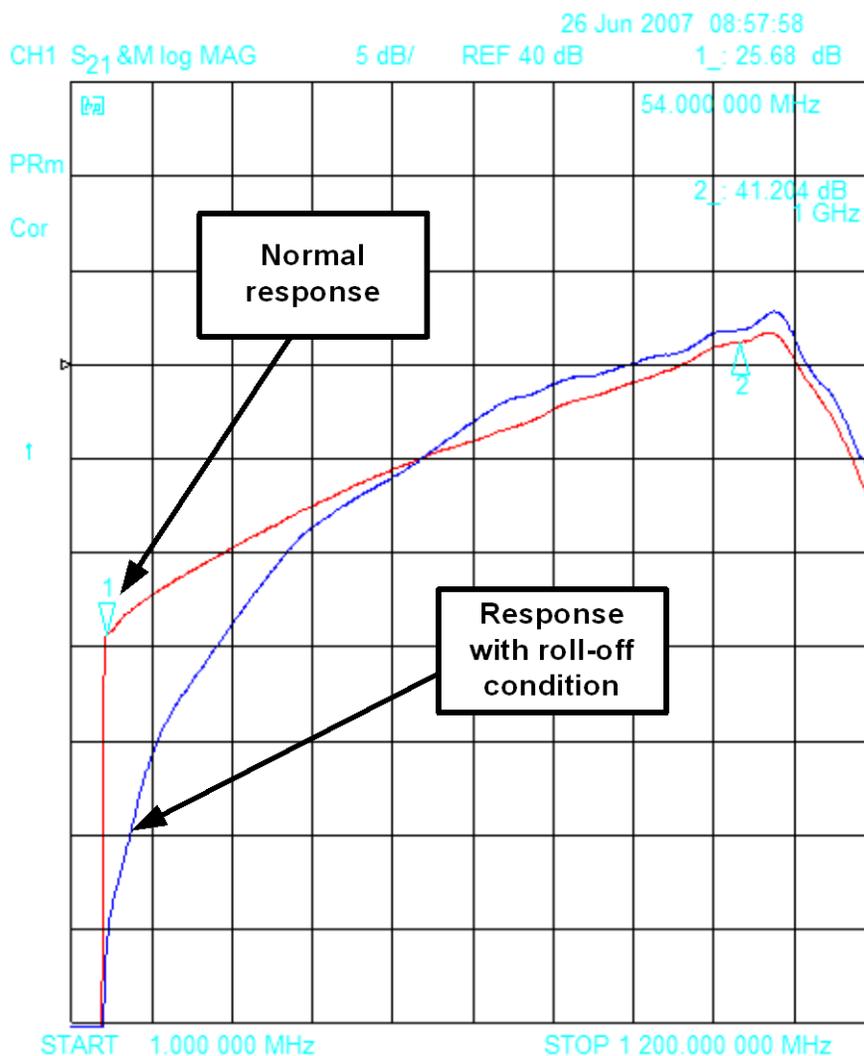
An issue was discovered recently with 1 GHz GainMaker® System Amplifiers exhibiting signal roll-off in the lower portion of the forward frequency band. The roll-off occurs when one or more capacitors in the pre-amplifier section become fractured. The effect of the damaged capacitor(s) on performance is most significant and noticeable in the lower portion (channels 2-6) of the forward band.

Reduced gain in the forward band, particularly at low frequencies, is a symptom of a possible fractured-capacitor condition. In the figure below, the plot labeled **Normal response** shows typical amplifier or node gain at 54 MHz. The plot labeled **Response with roll-off condition** shows the greatly reduced gain at the lower end of the band.

Note: This plot shows a gain reduction of nearly 15 dB at 54 MHz, but as little as 5 dB gain reduction at 54 MHz may indicate a fractured-capacitor condition.

If an amplifier exhibits the trouble symptom described in this document, we recommend returning the unit to Cisco for repair or replacement. Refer to *For Information* (on page 5).
