Troubleshoot FTD Unable to Ping Upstream Device despite Having an ARP Entry

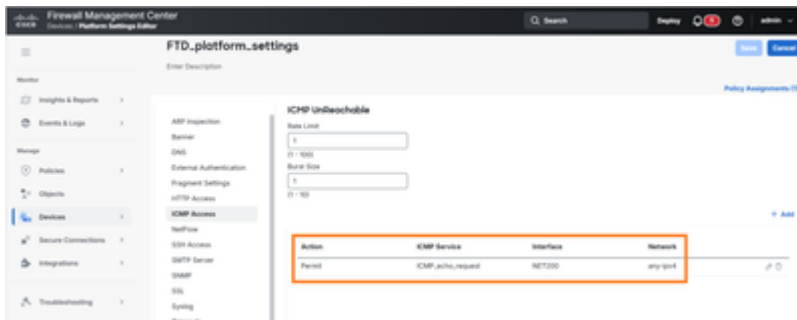
Locate the ICMP rule in the platform settings that is configured to deny ping traffic.

In this example the ICMP rule permits only ICMP echo requests to be accepted by the FTD interface.

The root cause of this issue was an ICMP rule configured in the platform settings that was explicitly denying ICMP echo replies traffic. While the firewall maintained proper Layer 2 connectivity (evidenced by the visible ARP entries), the platform-level ICMP rule was blocking Layer 3 ICMP echo reply packets, preventing successful ping operations to the upstream IP address. This type of configuration can occur when security policies are implemented to restrict ICMP traffic but can inadvertently affect legitimate network connectivity testing and monitoring.

Modify the identified ICMP rule to allow ping traffic or remove the blocking configuration as appropriate for the network security requirements and operational needs.

Action	ICMP Service	Interface	Network
Permit	ICMP_echo_request	NET200	any ipv4
Permit	ICMP_echo_reply	NET200	net,192.0.2.0
