Troubleshoot ACI Dual Role Switch and Intel VIC Card

Introduction

This document describes the use of dual-role switches in the Application Centric Infrastructure (ACI) fabric and the use of Intel Virtual Interface Cards (VICs).

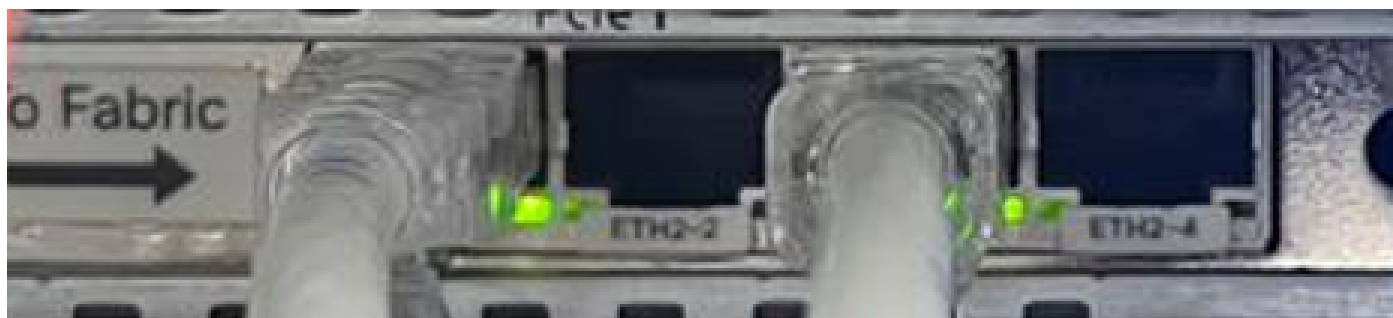
It was reported that the physical cable connections were made on APIC interfaces eth2-1 and eth2-3 but in the APIC GUI, it was found that interfaces eth2-2 and eth2-4 were showing up. Similar behavior was seen for all the three APICs in the cluster.

eth2-1	1500	50:7C:6F:31:6F:C8	down
eth2-2	1500	50:7C:6F:31:6F:C8	up
eth2-3	1500	50:7C:6F:31:6F:C8	down
eth2-4	1500	50:7C:6F:31:6F:C8	up

Intel X710-T4 Quad-port 10GBase-T NIC, it has the port numbering scheme starting on the right port and incrementing going towards the left port.

Ports are assigned numbers from right to left in this manner:

| eth2-4 | eth2-3 | eth2-2 | eth2-1 |

With this numbering scheme in mind, APIC is detecting correct ports and showing ports on GUI as expected.

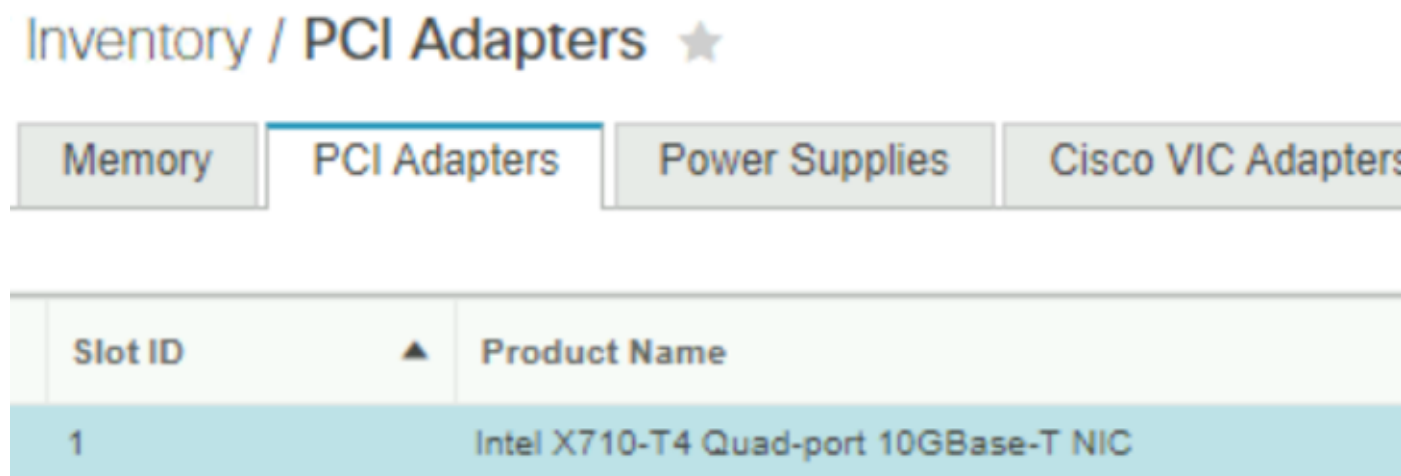
The user was using the Peripheral Component Interconnect Express (PCIe) slot - APIC-PCIE-IQ10GC Intel X710 quad Port 10GBase-T network interface, not the Cisco VIC cards.

Verify in Cisco Integrated Management Controller (CIMC), chassis > Inventory > PCI Adapters.

It was confirmed that the NIC mode in CIMC is dedicated to all three CIMCs, along with the Trusted Platform Module (TPM) status enabled and ownership owned. All other outputs look fine too. Later, a software defect (Cisco bug ID [CSCwd21587](#)) was filed to further troubleshoot the issue.
