Cisco HyperFlex Software Advisory for HX Release 4.0(2c)

Software Advisory for [CSCvw39220](#): Internal scheduled job to cleanup old system files

Software Advisory for CSCvw01432: Moving Existing HyperFlex ESXi Hosts to vCenter 7.0 Update 1 Can Unexpectedly Power Off and Delete the HyperFlex Controller VMs

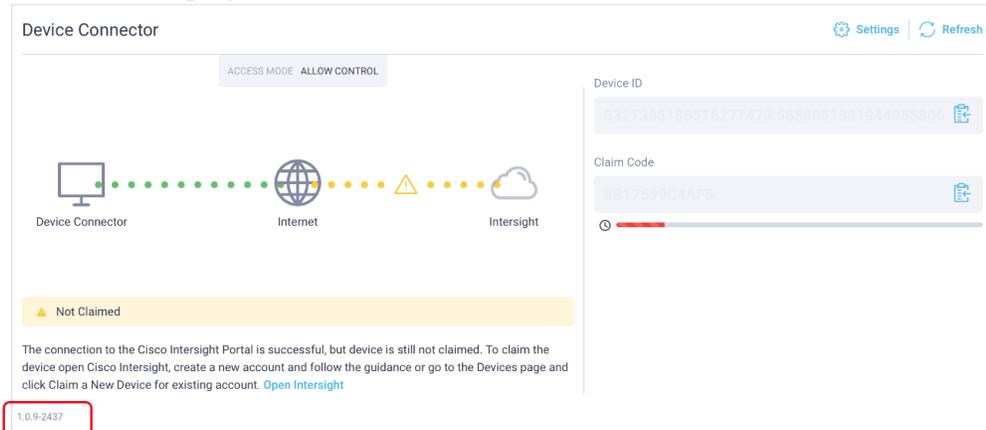
- b) To verify the Device Connector version, login to HX Connect and navigate to “Settings” > “Device Connector”, and the Device Connector version number is displayed on the lower left of the modal.
