# UCS M5前端DIMM人口卷标不匹配文档

本文描述不反射当前线文档的老UCS M5前端DIMM人口卷标的一个问题。

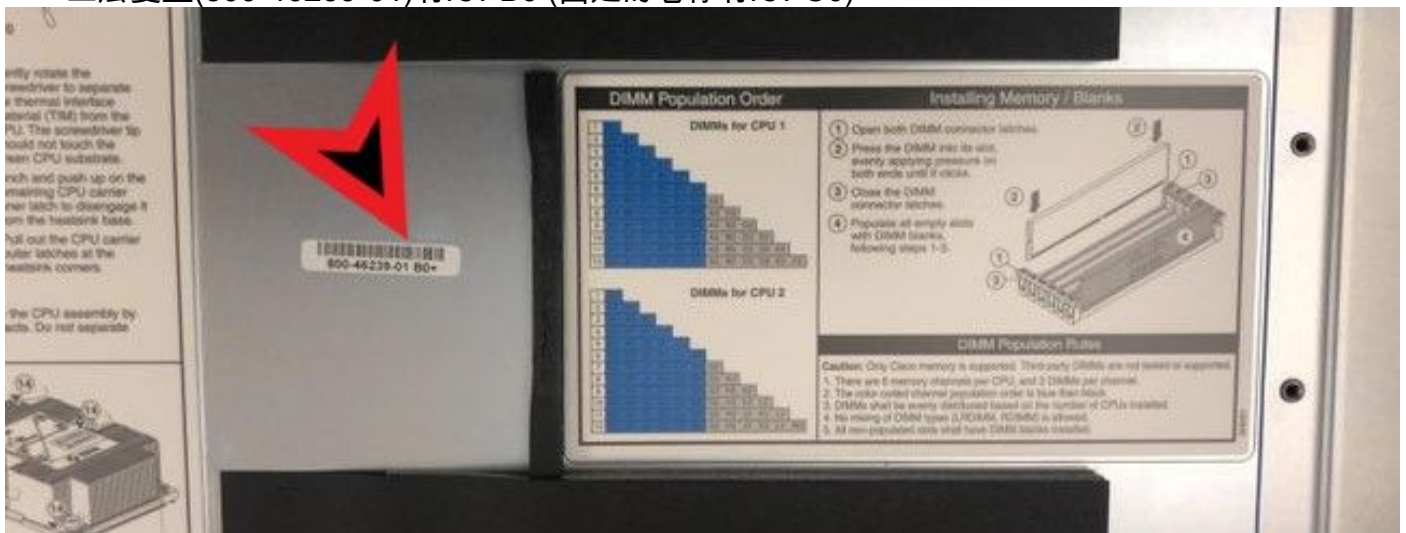
- UCS B200 M5
- UCS B480 M5
- 上层复盖(800-46239-01)有rev B0 (固定的卷标有rev C0)

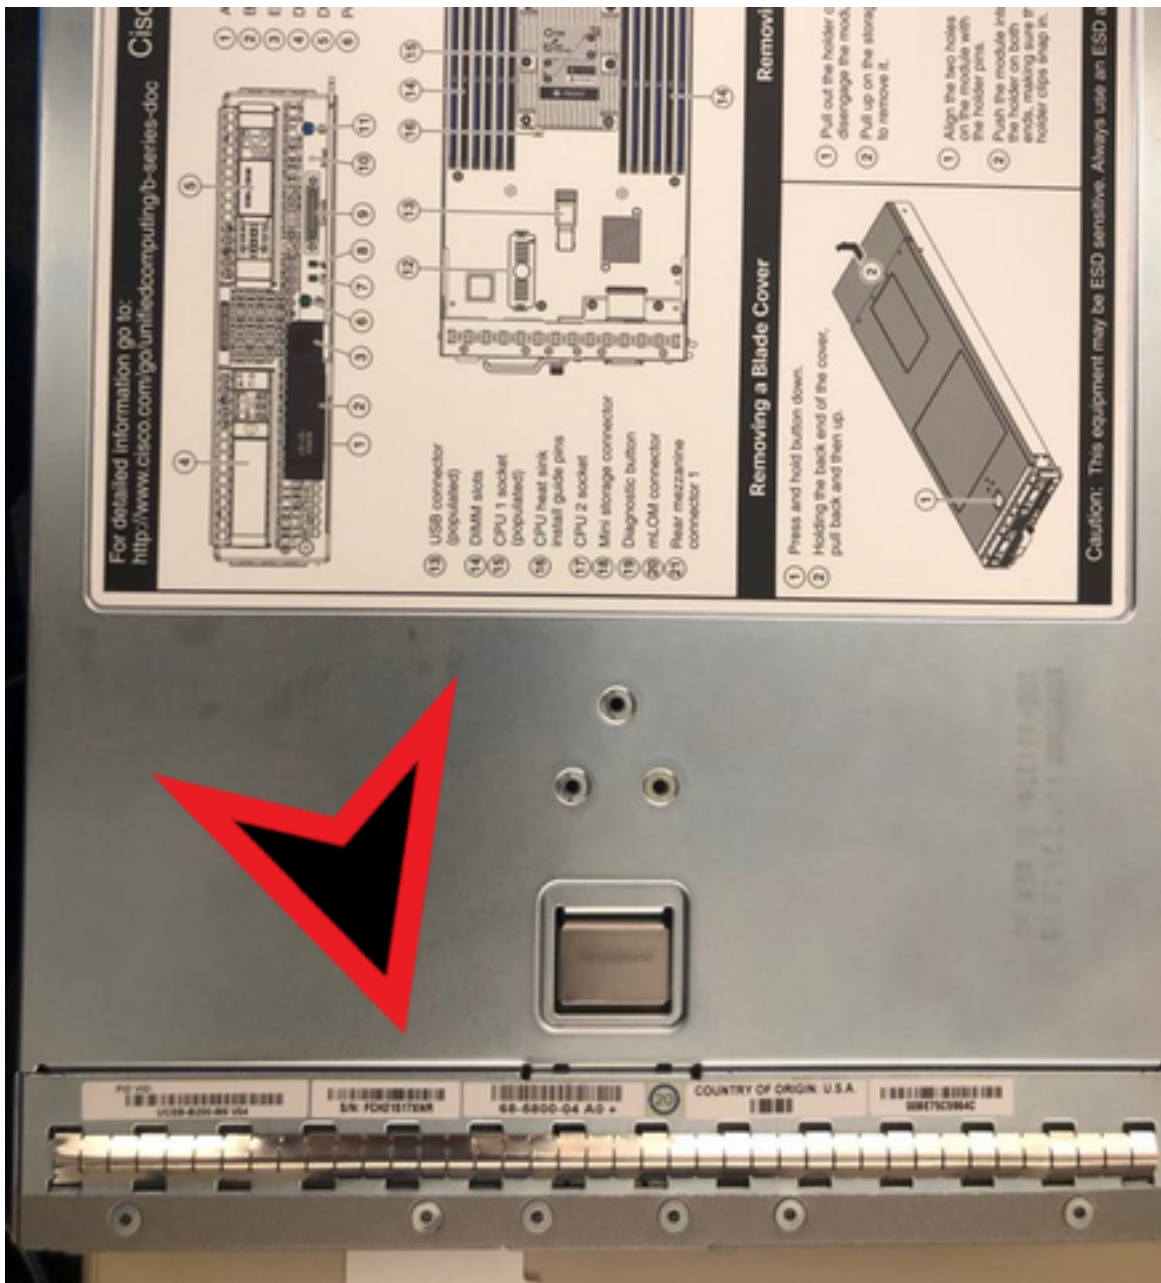
- 顶层装配编号(68-5800-04)有rev A0 (修正版本是B0)

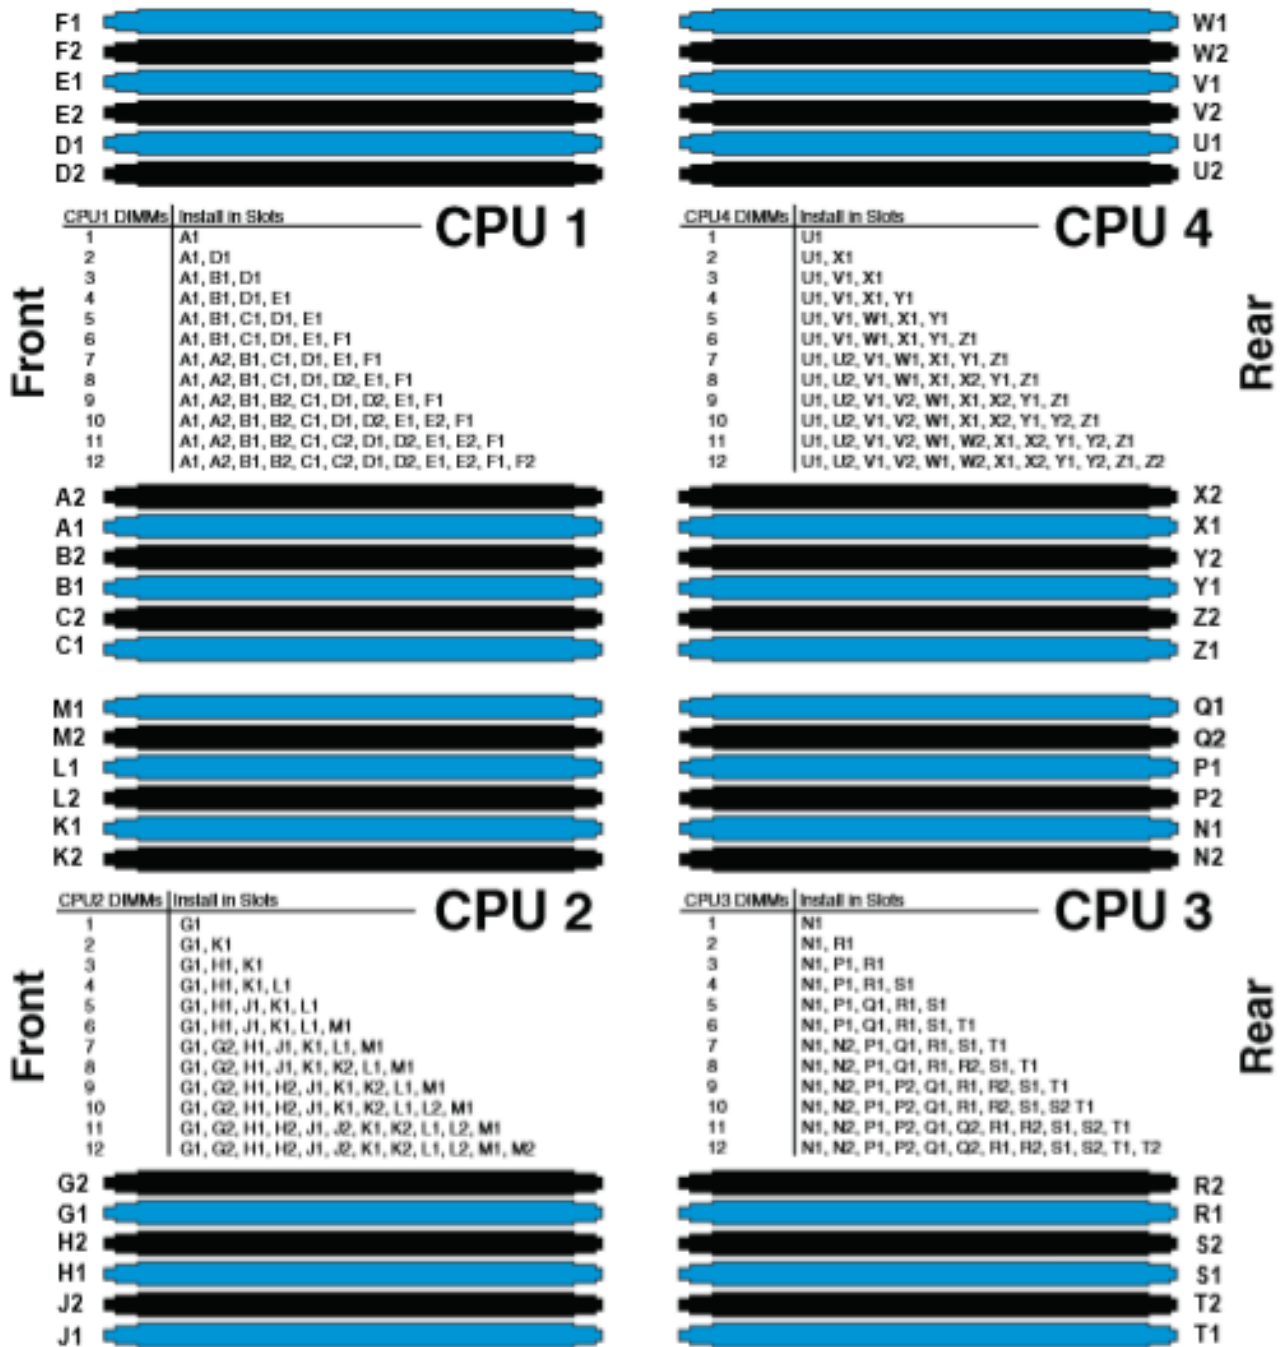
# Cisco UCS B480 M5 Memory Slot Locations

供参考，这是从B480-M5的老卷标：

原始DIMM人口卷标不是不正确的，但是用户应该被导向到最新和最最佳的配置的线文档。
