使用Bidir PIM配置對不通過FTD防火牆的組播流量進行故障排除

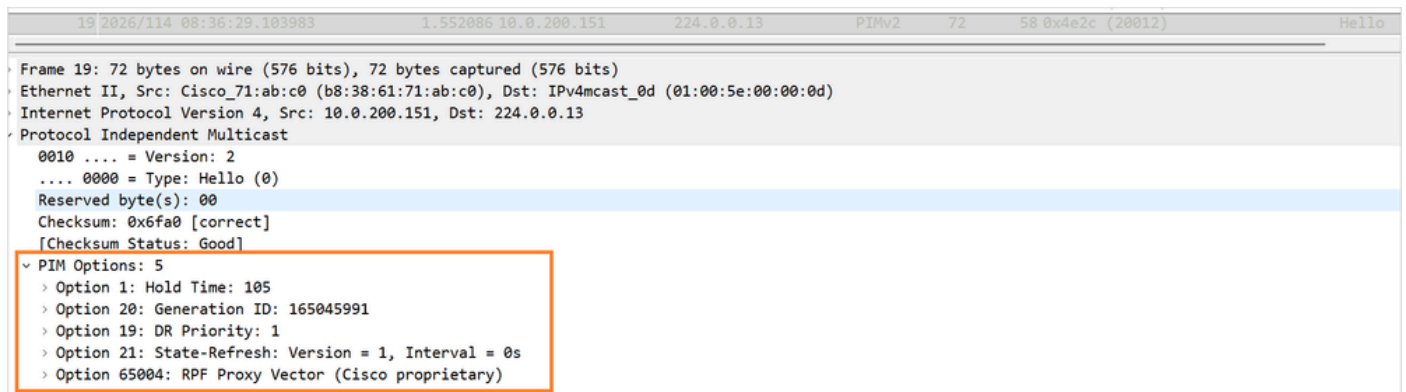
PIM_Hello_Options_no-bidir-capable.png

PIM Hello資料包包含以下選項：

請注意沒有支援Bidir的標誌。

步驟 7:在10.0.200.151鄰居上啟用雙向PIM。

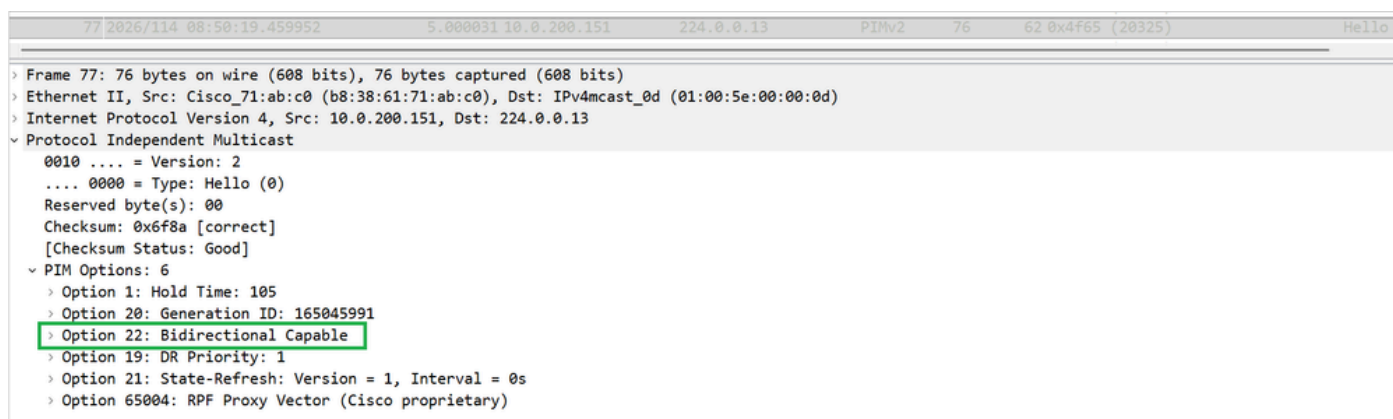
PIM_Hello_Options_option22.png

步驟 8:收集新捕獲並檢查鄰居10.0.200.151的PIM Hello選項。顯示PIM選項22 (雙向支援)：

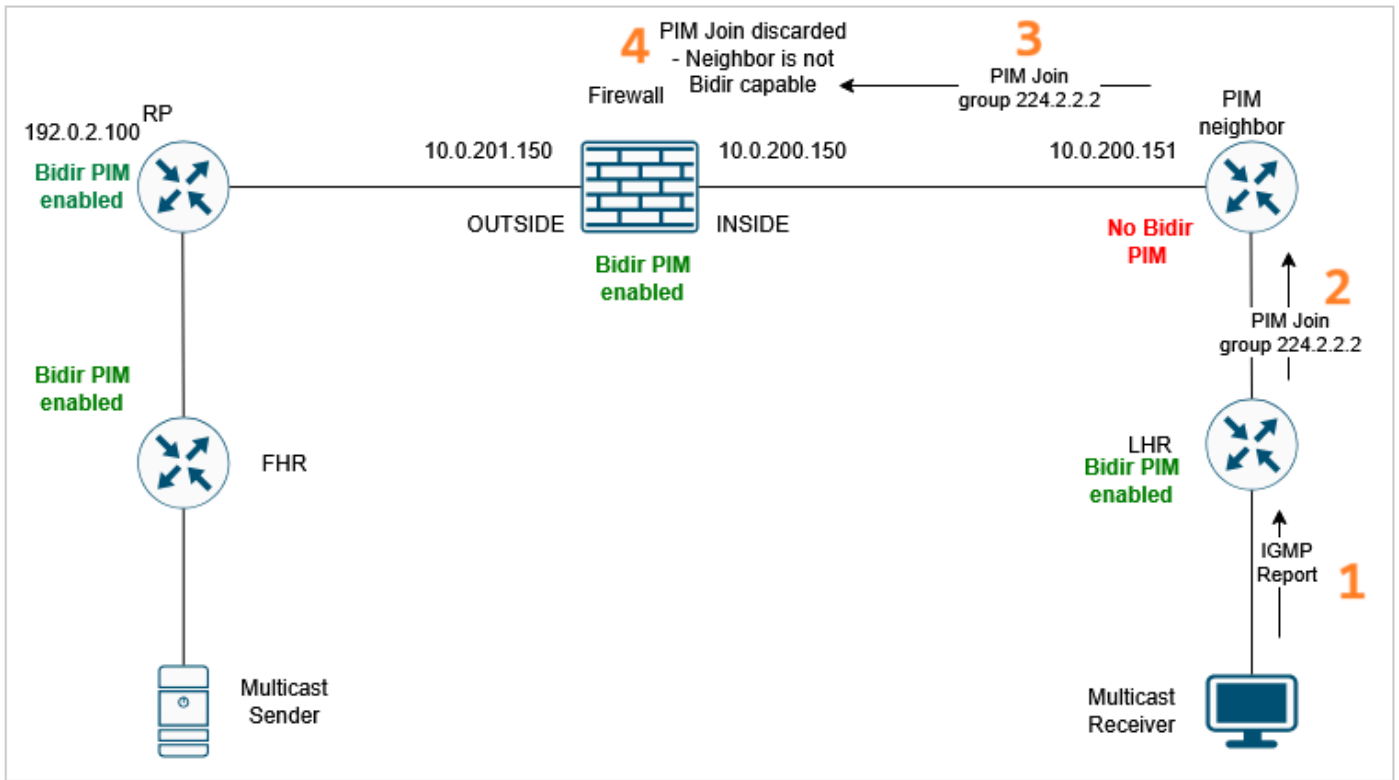
原因.png

組播流量故障是由相鄰網路裝置上的不正確或不完整組播和雙向PIM配置引起的。特定組態問題導致FTD放棄特定多點傳送群組的PIM加入/修整訊息。因此，防火牆無法為組播流量建立mroute。對於要通過防火牆資料平面的組播資料流量，控制平面(PIM)必須建立正確的路由。
