BTM CGW Abrt Frms Errors

Document ID: 10848

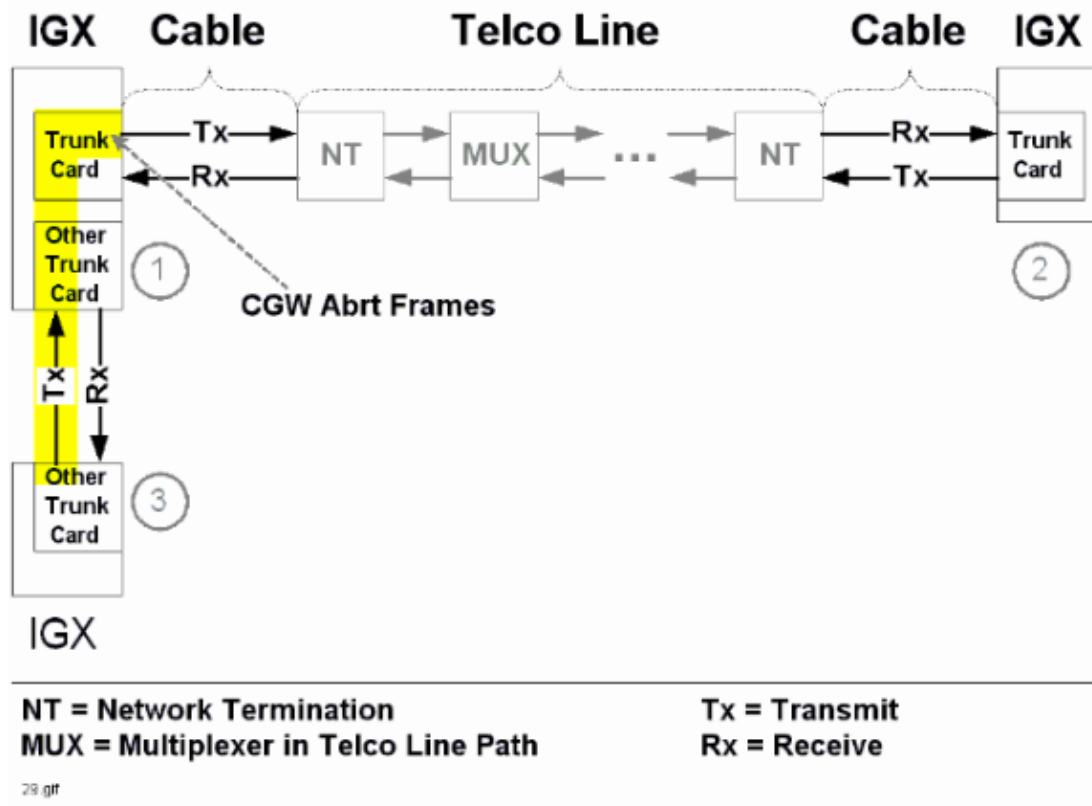
The likely location of equipment errors is highlighted in yellow.

4. Issue the SuperUser level **dspchstats** command to view discarded frames from the network.
5. In the error example above, the **dsptkcons** command was issued on the BTM trunk in IGX1. Assume this displays IGX2 as a Src Node. **vt** to IGX2 and look through all connections displayed after you issue the **dsprts** command to find a FR or FF connection that traverses the BTM trunk in IGX1. This may not be practical if there is a very large number of connections.

7. If there are discarded frames on a connection, refer to the route to see which trunks they have crossed before traversing the BTM trunk in IGX1.
8. If the connection terminates on IGX3 and traverses the *Other Trunk Card* shown in the above graphic, then investigate the trunk as the cause of CGW Abrt Frms errors.

9. Check **dsptkerrs** on IGX1 to see if there are indications that trunk quality is deteriorating. Troubleshoot those trunk errors first.
10. In networks with a few trunks, issue the **dsptkerrs** command on the trunks in the proximity of the

11. Make sure that the IGX chassis is properly grounded. Incorrect or insufficient grounding can cause problems.
