# BTM CGW Dscd Cells Errors

Document ID: 10849

This document discusses the BTM CGW Dscd Cells error and provides steps on how to troubleshoot this error message.

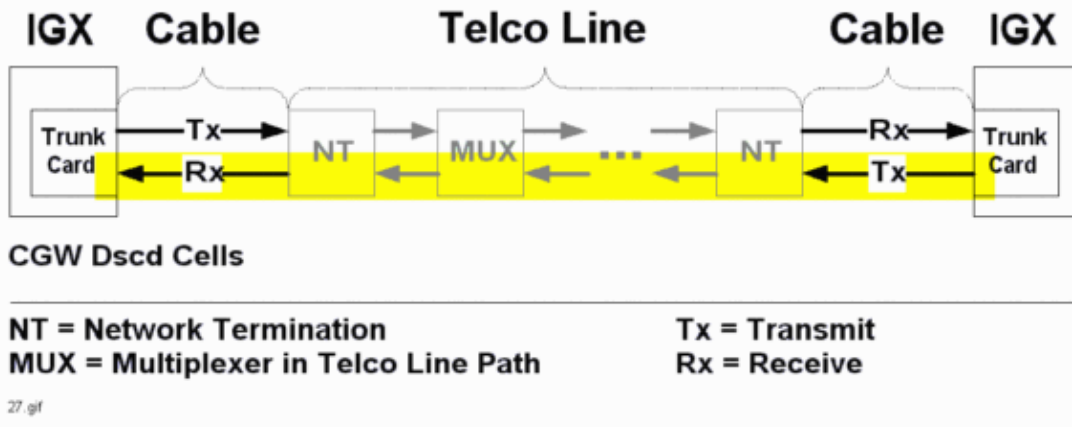
## Error Example

CGW Dscd Cells errors indicate that the complex gateway (CGW) function of the BTM has discarded an ATM Adaptation Layer-5 (AAL5) protocol data unit (PDU) in the ingress direction. The ingress direction is from the network to BTM. CGW is not a type of traffic flow. CGW generates legacy StrataCom Trunk Interface (STI) or standard AAL5 ATM cell payloads out of FastPackets. The BTM trunk card can convert FastPackets into AAL5 ATM cells. The CGW Dscd Cells error counter begins to increment after an AAL5 PDU, which has a bad cyclic redundancy check (CRC-32) value, has been reassembled from ATM cells received from the trunk. This is typically caused by bit errors on the Telco line or by faulty hardware.

The likely location of equipment errors is highlighted in yellow.
