BTM CGW Dscd Pkts Errors

Document ID: 10850

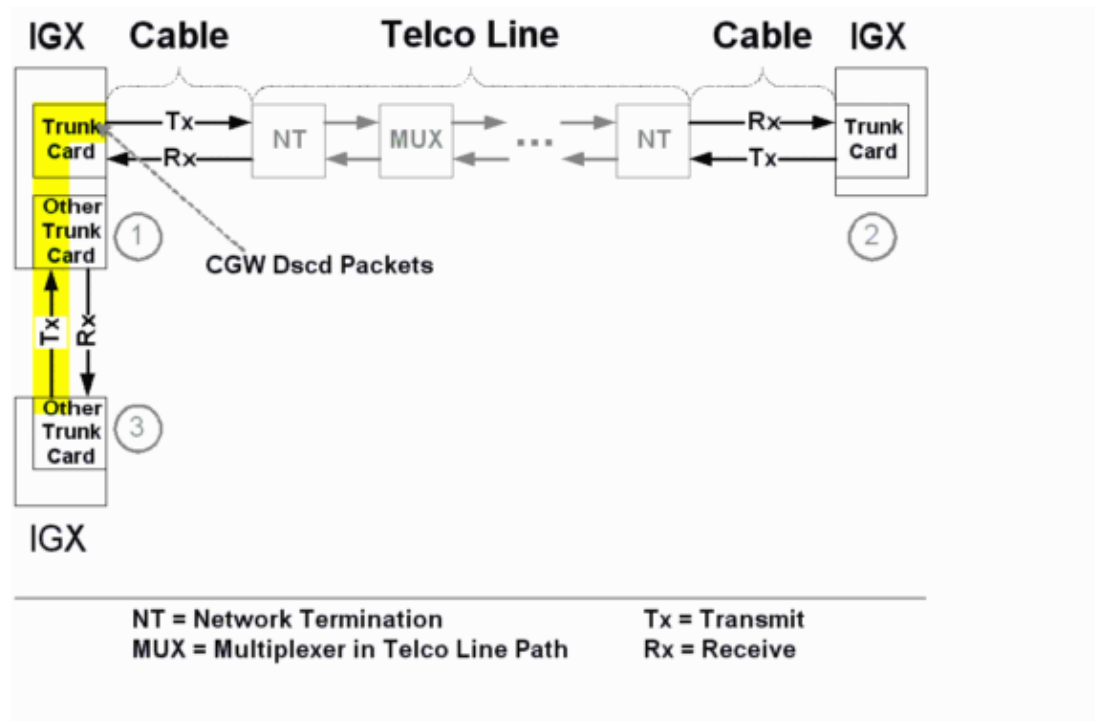
Error Example

The likely location of equipment errors is highlighted in yellow.

7. If there are discarded frames on a connection, refer to the route to see which trunks they have crossed before traversing the BTM trunk in IGX1.
8. If the connection terminates on IGX3 and traverses the Other Trunk Card shown in the above graphic, then investigate the trunk as the cause of CGW Dscd Pkts errors.

9. Check dsprkerrs on IGX1 to see if there are indications that trunk quality is deteriorating. Troubleshoot those trunk errors first.
10. In networks with a few trunks, issue the **dsprkerrs** command on the trunks in the proximity of the node that shows CGW Dscd Pkts errors to check for trunk errors. The trunk that causes payload corruption might be located multiple hops away from the BTM trunk that is incrementing CGW Dscd Pkts errors.

11. Make sure that the IGX chassis is properly grounded. Incorrect or insufficient grounding can cause problems. Refer to Power and Grounding for more information on grounding a chassis.
