BTM Loss of Sig (Red) Error

Document ID: 10853

This document applies to the Cisco IGX switch broadband trunk module (BTM) with E1, E2, E3, and T3 backcards.

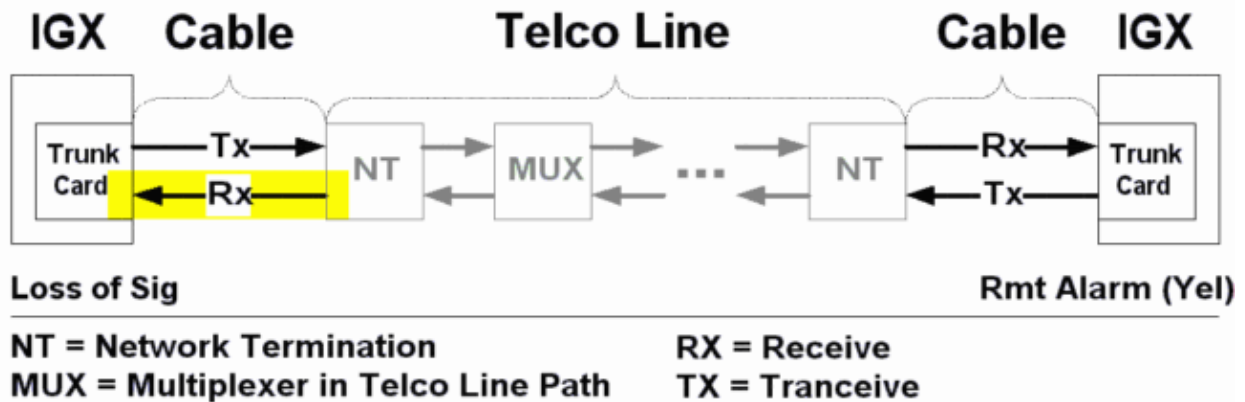
The integrated trunk error `Loss of Sig` indicates that there has been a loss of signal (LOS). The BTM declares a LOS alarm when the signal level at the receiver falls below a minimum acceptable level. A LOS is a Physical Layer error and typically results in an integrated alarm.

The likely location of equipment errors is highlighted in yellow.

1. Both ends of the trunk must be active during troubleshooting. Issue the **dsptrks** command to verify that the trunk is active. If the trunk number is not displayed in the **dsptrks** screen, the trunk is not active. To activate a trunk, issue the **uptrk** command.

2. Check cabling between the trunk card and the next device upstream. Typically this is the local channel service unit (CSU) or the Network Termination (NT).

- d. Wait at least ten seconds longer than the Red Alm Out timer setting in **cnftrkparm** to verify the trunk status change.
3. Check local hardware by placing a loopback plug onto the connector at the backcard of the BTM. Alternatively, place the CSU or the NT into the loop toward the customer premises equipment (CPE), which is the node. If the trunk status in **dsptrks** changes to Clear-OK and **dsptrker** no longer shows incremental errors, the trunk and backcard are working properly. Wait at least ten seconds longer than the Red Alm Out timer setting in **cnftrkparm** to verify the trunk status change.

4. Check line coding and line framing settings by using the **dsptrkenf** command. In some cases, the next equipment upstream does not send a proper signal until it receives a signal from the equipment on the other end of the wire. If the BTM trunk is not configured for correct framing, the multiplexers might not send a signal, which will look to the IGX like a cable problem. Changing the framing configuration should fix the problem.

5. Check the Telco line by placing a loopback plug onto the CSU or NT to loop it back toward the Telco line. If the remote end trunk shows a change from a Yel Alm Out to Clear-OK, the Telco line is working properly. Wait at least ten seconds longer than the Yel Alm Out timer setting in **cnftrkparm** to verify the trunk status change.

6. Contact your service provider and have the line checked.
