BTM Loss of Signal Errors

Document ID: 10854

This error applies to the IGX broadband trunk module (BTM) with E1, E2, E3, and T3 backcards.

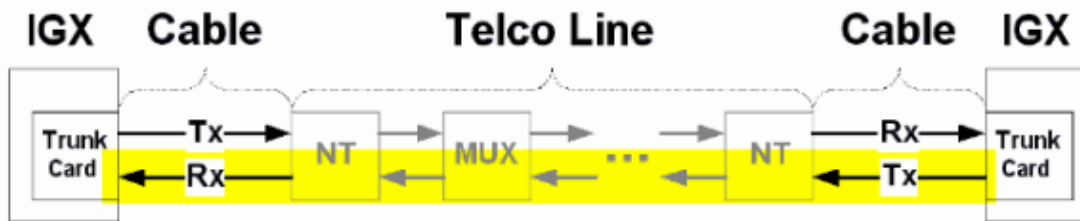
This statistical trunk error indicates that a loss of signal (LOS) has occurred. The BTM logs a LOS error when the signal level at the receiver falls below an acceptable level. LOS is a physical layer error and typically results in an integrated alarm.

The likely location of equipment errors is shown in yellow:
