# BTM Out of Frms (RED) Error

Document ID: 10855

This error applies to the IGX broadband trunk module (BTM) with E1, E2, E3, and T3 backcards.

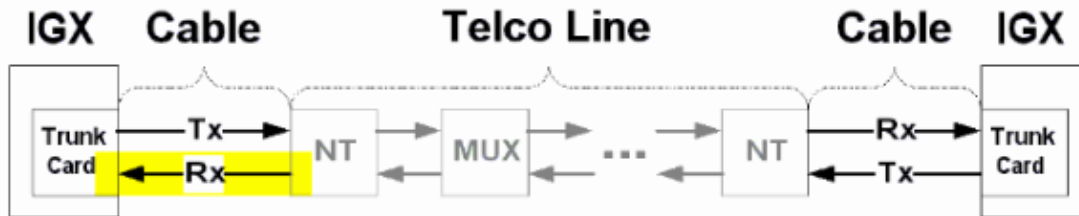
Out of Frames

The likely location of equipment errors is shown in yellow:
