BTM Out of Frame Errors

Document ID: 10856

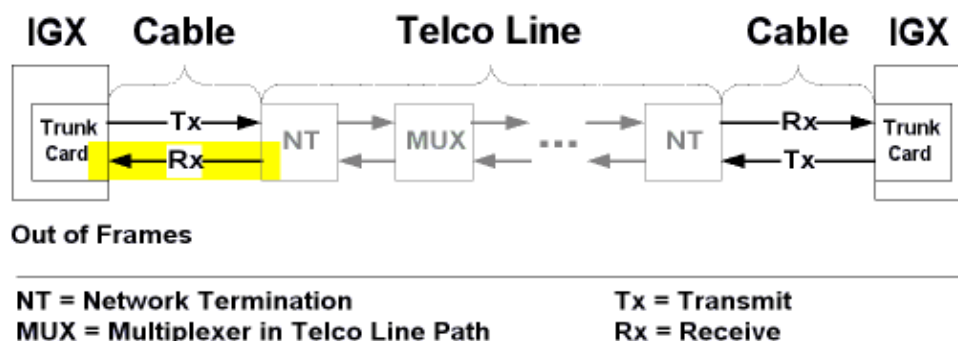
The OOF or LOF condition occurs when errors in the framing pattern are detected by the BTM backcard receiver. This error represents consecutive errors in the terminal framing bits.

The likely location of equipment errors is shown in yellow:
