BTM P-bit Parity Errors

Document ID: 10858

This document discusses the Broadband Trunk Module (BTM) parity bit (P-bit) error and provides steps to troubleshoot this error message.

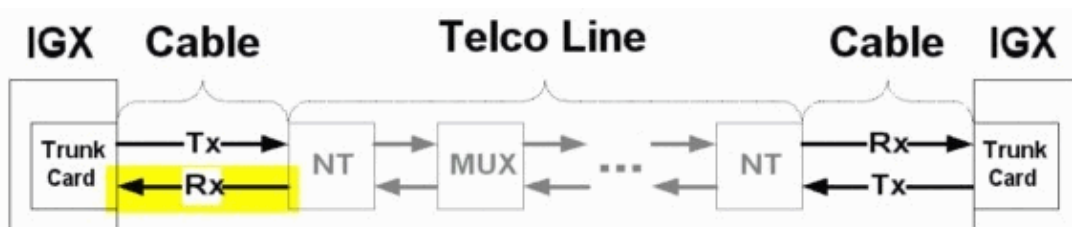
P-bit Parity Errs

The likely location of equipment errors is highlighted in yellow in this diagram:
