# BTM PLCP Out of Frame Errors

Document ID: 10859

This document discusses the Broadband Trunk Module (BTM) Physical Layer Convergence Protocol (PLCP) Out of Frames error and provides steps to troubleshoot this error message.

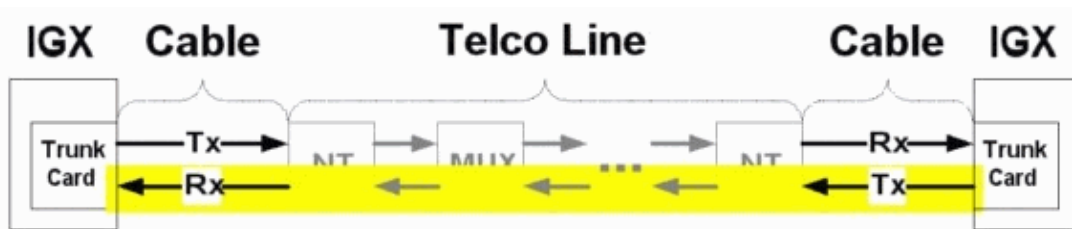
**BIP-8 Code Errs (on T3 with PLCP)**

The BTM T3 transports ATM cells via PLCP framing. The BTM T3 interface card does not map ATM cells directly onto the T3 frame. PLCP framing only achieves a cell transfer rate of 40.704 Mbps. PLCP Out of Frame Errs errors occur after the receiver loses synchronization with the PLCP framing. Because PLCP framing is generated and used by the terminating BTMs, the problem can occur anywhere on the link between the two trunk cards or on the two trunk cards themselves.

The likely location of equipment errors is highlighted in yellow in this diagram:
