BTM Rx Hi-Pri Pkt Drp Errors

Document ID: 10863

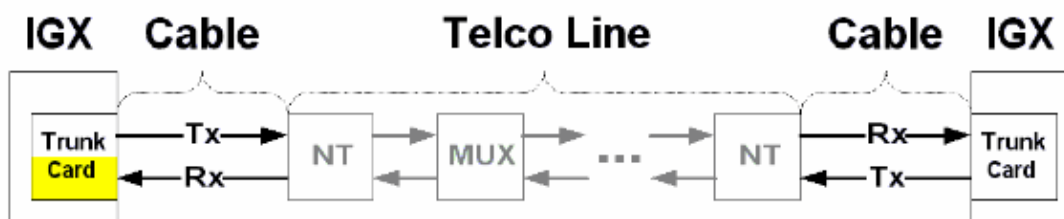
Rx Pkt Drop

The likely location of equipment errors is highlighted in yellow.
