BTM Tx BData A Pkt Drp Errors

Document ID: 10868

This document provides troubleshooting information on broadband trunk module (BTM) Tx BData A Pkt Drp errors.

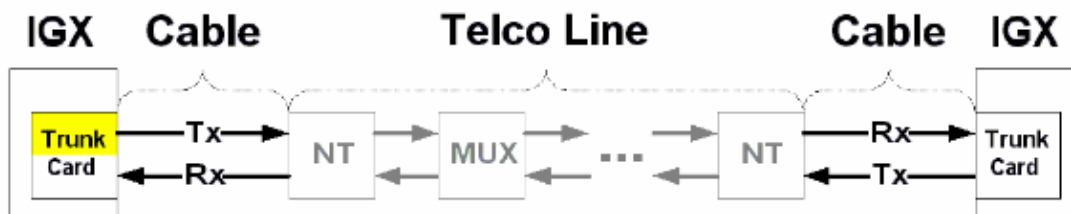
1E.gft

The likely location of equipment errors is highlighted in yellow here:

Tx Pkt Drop
