# BTM Tx BData B Pkt Drp Errors

Document ID: 10869

This document provides troubleshooting information on broadband trunk module (BTM) Tx BData B Pkt Drp errors.

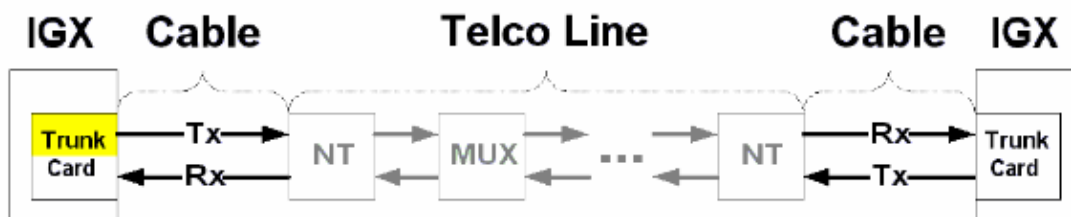
1E.gf

The likely location of equipment errors is highlighted in yellow.

Tx Pkt Drop
