BTM Tx CC Pkt Drp Errors

Document ID: 10870

This document discusses broadband trunk module (BTM) Tx CC Pkt Drp errors and provides steps to troubleshoot these errors.

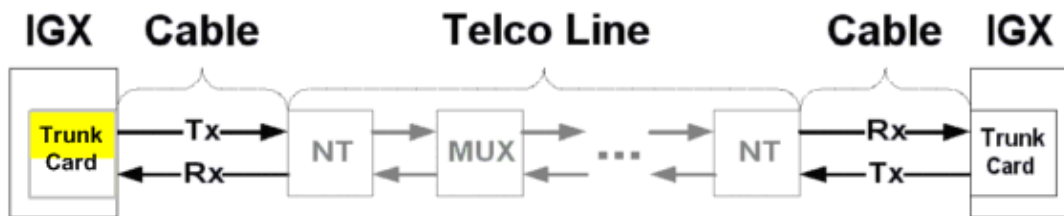
Tx Pkt Drop

The likely location of equipment errors is highlighted in yellow in this diagram:
