NTM AIS (Blu) Errors

Document ID: 10873

This document discusses Network Trunk Module (NTM) alarm indication signal (AIS) blue errors.

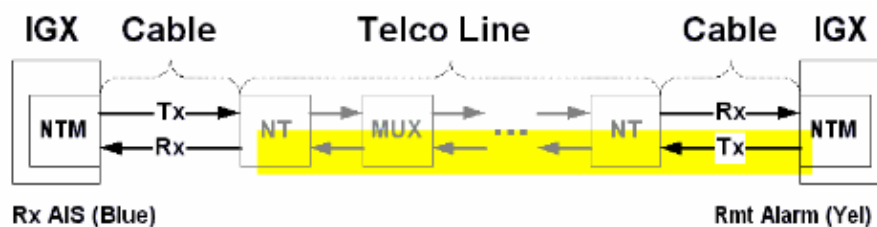
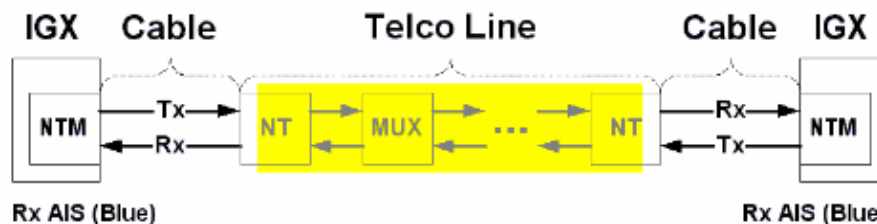
The likely location of equipment errors is highlighted in yellow.
