# NTM Tx CC Pkt Drp Errors

Document ID: 10886

This document discusses network trunk module (NTM) Control Card (CC) packet drop errors and provides steps to troubleshoot these errors.

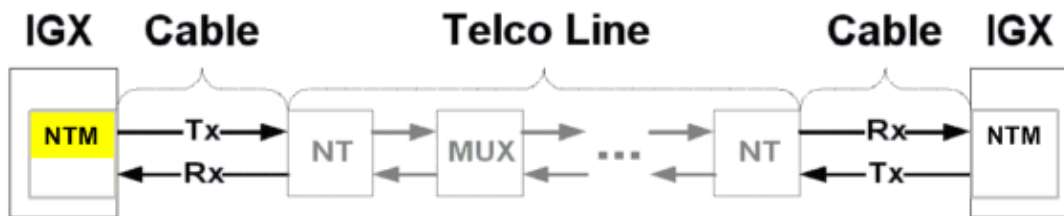
### Tx CC Pkt Drop

Tx CC Pkt Drps can have these causes:

- The High Priority queue that carries CC packets can overflow during periods of unusually high internodal traffic. The internodal protocol is robust enough to recover from the loss of a small number of CC messages. Sustained periods of CC Pkt Drps can cause Comm Fails between nodes, which can lead to Comm Break and unreachable nodes.

CC Pkt Drps rarely occur in networks with T1 trunks or greater bandwidth. When accompanied by Comm Fail and Comm Break messages in **dsplog** command output, then Cisco Technical Support must troubleshoot CC Pkt Drps.

- Incorrectly configured trunk parameters, as indicated in the SuperUser-level **cnftrkparm** command.

The likely location of equipment errors is highlighted in yellow in this diagram:

1. Determine if there is more than one trunk that is experiencing CC Pkt Drps, between the IGX and the rest of the network.
  - a. Issue the **dsptrks** command, to verify the number of routing trunks at the local IGX.
  - b. If more than one trunk to the network exists, issue the SuperUser-level **drtop** command, to identify the trunk that CC traffic uses at the local IGX. The **Via Trk** column of the **drtop** output indicates the trunks that are used for CC traffic at the local IGX.
  - c. Issue the **dspnds** command, to determine if there are unreachable nodes on the network.
  - d. Issue the **cnftrk** command and set **Restrict PCC traffic** to **Yes**, to route CC traffic off of the trunk that is experiencing CC Pkt Drps.
2. Verify that all trunk parameters are correctly configured.

- a. Compare the configuration of the problem trunk to the default values or to the configuration of other trunks of the same type that work properly.
  - b. Issue the **cnftrkparm** command, to verify the settings of the HighPri queue.
  - c. If there is a difference between the configuration of the trunk that is experiencing CC Pkt Drps and the configuration of a working trunk at the same IGX, then contact Cisco Technical Support for further assistance.
3. Issue the SuperUser-level **cnfnodeparm** command, to check all nodal parameters.
    - a. Compare the settings of the IGX that is experiencing the CC Pkt Drps to the settings of an error-free IGX.
    - b. If a configuration difference is noted between the IGX that is experiencing CC Pkt Drps and the error-free IGX, contact Cisco Technical Support for further assistance.
