UXM Loss of Sig (Red) Errors

Document ID: 10899

This document discusses the Universal Switching Module (UXM) Loss of Sig (Red) errors and provides steps to troubleshoot these errors.

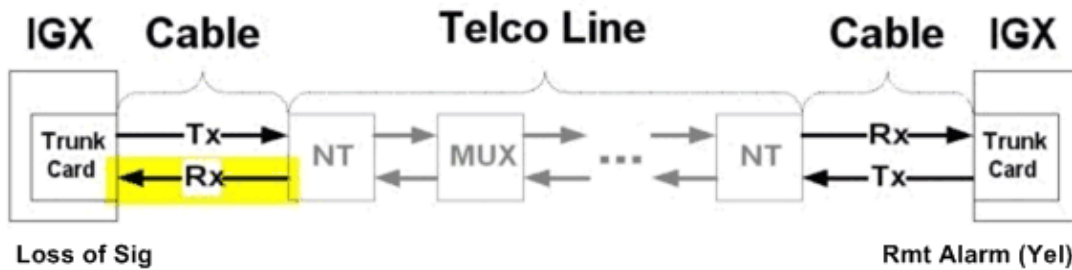
The Loss of Sig integrated trunk error indicates that there has been a loss of signal (LOS). The UXM declares a LOS alarm when the signal level at the receiver falls below a minimum acceptable level. A LOS is a physical-layer error, and it typically results in an integrated alarm.

The likely location of equipment errors is highlighted in yellow in this diagram:

1. Issue the **dsprks** command to verify that the trunk is active. If the trunk number is not displayed in the **dsprks** command output, then the trunk is not active. To activate a trunk, issue the **uptrk** command.
2. Check the cabling between the trunk card and the next device upstream. Typically this is the local channel service unit (CSU) or the Network Termination (NT).
 - a. Issue the **dsprks** command at the distant-end node. If the remote end of the trunk is in the Yellow alarm condition, a one-way problem likely exists.

- b. Leave the local cable connected to the trunk card, but remove it from the CSU or NT.
 - c. Put a loopback plug on the disconnected end of the cable. If the trunk status in **dsprks** changes to `Clear-OK`, then the cable is working properly.

- d. Wait at least 10 seconds longer than the `Red Alm Out` timer setting in **cnftrkparm**, to verify the trunk status change.
3. Place a loopback plug onto the connector at the backcard of the UXM, to check the local hardware. Alternatively, place the CSU or the NT into the loop toward the customer premises equipment (CPE), which is the node.

- a. If the trunk status in **dsprks** changes to `Clear-OK`, and **dsprkerrs** no longer shows incremental errors, then the trunk and backcard are working properly.

- b. Wait at least 10 seconds longer than the `Red Alm Out` timer setting in **cnftrkparm**, to verify the trunk status change.
4. Issue the **dsprkcnf** command to check the line coding and line framing settings.

In some cases, the next equipment upstream does not send a proper signal until it receives a signal from the equipment on the other end of the wire. If the UXM trunk is not configured for correct framing, the multiplexers might not send a signal; this will look like a cable problem, at the IGX. If

you change the framing configuration, it should fix the problem.

5. Place a loopback plug onto the CSU or NT, to loop it back toward the Telco line, to check the Telco line.
 - a. If the remote end trunk shows a change from a `Ye1 Alm Out` to `Clear-OK`, then the Telco line is working properly.
 - b. Wait at least 10 seconds longer than the `Ye1 Alm Out` timer setting in **`cnftrkparm`**, to verify the trunk status change.
6. Contact your service provider and have the line checked.
