Why are OSPF Neighbors Stuck in Exstart/Exchange State?

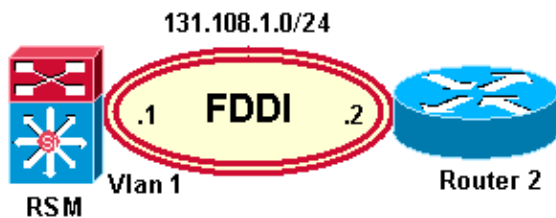
The above diagram shows a Fiber Distributed Data Interface (FDDI) port on a Cisco Catalyst 5000 with a Route Switch Module (RSM) connected to a FDDI interface on Router 2. The Virtual LAN (VLAN) on the RSM is a virtual Ethernet interface with a MTU of 1500, and the FDDI interface on Router 2 has a MTU of 4500. When a packet is received on the FDDI port of the switch, it goes to the backplane and the FDDI to Ethernet conversion/fragmentation happens within the switch itself. This is a valid setup, but with MTU mismatch detection feature, OSPF adjacency is not formed inbetween the router and the RSM. Since FDDI and Ethernet MTU are different, this **ip ospf mtu-ignore** command is useful on the VLAN interface of the RSM so that OSPF stops detecting MTU mismatch and forms the adjacency.

In Cisco IOS Software 12.01(3), the **ip ospf mtu-ignore** interface configuration command was also introduced to turn off the MTU mismatch detection; however, this is only needed in rare instances, as shown in this diagram:
