# Why Doesn't PIM Sparse Mode Work with a Static Route to an HSRP Address?

Document ID: 13783

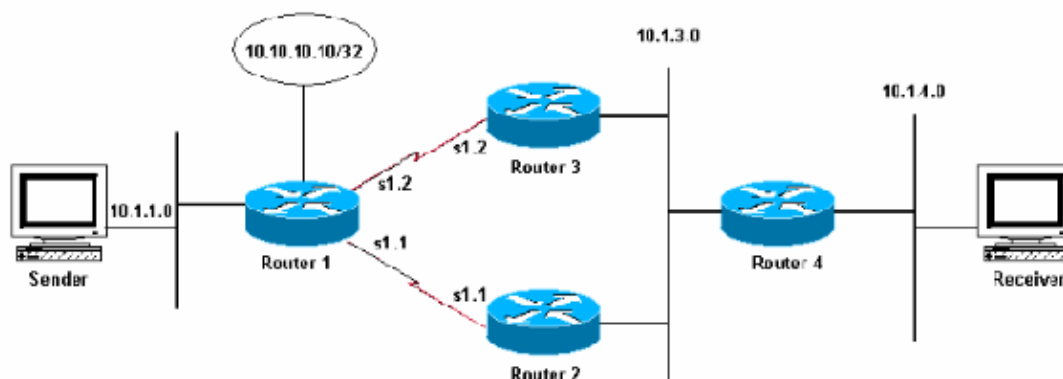
## Network Diagram

In the figure above, Routers 2 and 3 are talking HSRP on subnet 10.1.3.0, and Router 2 is the active router. Routers 1, 2, and 3 are talking Enhanced Interior Gateway Routing Protocol (EIGRP), and Router 4 has a static default route to the HSRP virtual address.

In the example, the RPF neighbor is 10.1.3.3, which is the HSRP standby address used by the default static route. However, this address is not listed as a PIM neighbor. The reason the HSRP standby address is not listed as a PIM neighbor is because the two routers running HSRP (Routers 2 and 3) will not source the PIM neighbor messages from the HSRP standby address.

To solve the problem, change Router 4's configuration so the RPF neighbor is also a PIM neighbor. Do this by including Router 4 in the EIGRP process so that it now learns the RP address through EIGRP.

**Note:** Instead of including Router 4 in the EIGRP process (the preferred method), add static mroutes to Router 4 to make it RPF to the real routers' IP addresses because mroutes are preferred over the unicast routing table in RPF checks. For example, add **ip mroute 0.0.0.0 0.0.0.0 10.1.3.2**.
