# Understanding and Configuring DLSw and 802.1Q

Document ID: 26470

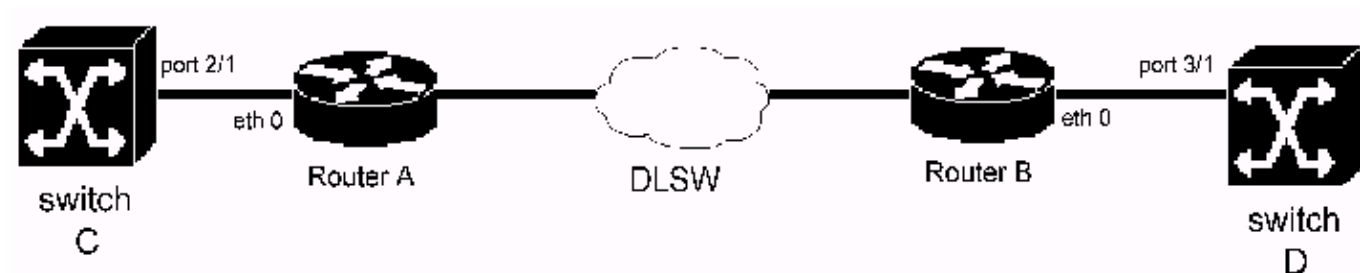
In the above topology, ethernet 0 of Router A connects to port 2/1 on Switch C. Ethernet 0 of Router B

connects to port 3/1 on Switch D. Interface ethernet 0 of both Router A and B is configured as a non-trunk port. DLSw is enabled on interface ethernet 0 of both Router A and B (transparent bridging is enabled on ethernet interface 0 of both Router A and B.) Router A and B form a DLSw peer connection.

If port 2/1 of Switch C is misconfigured as a trunk port, Switch C regularly sends out PVST+ BPDU frames to Router A. As Router A does not understand PVST+, Router A treats PVST+ BPDU frames as ordinary multicast frames. Thus, Router A sends the BPDU frames to Router B by DLSw. Similarly, Router B does not understand PVST+. When it receives PVST+ BPDU frames from Router A, it forwards the PVST+ BPDU frames to Switch D. When Switch D receives the PVST+ BPDU frames, it detects a problem (that is, Switch D receives PVST+ BPDU frames on a non-trunk port.) As a result, Switch D shuts down the port and logs %SPAN TREE-2-RX\_1QNONTRUNK: Rcvd 1Q-BPDU error messages on non-trunk port VLANs.

The solution is to locate the misconfigured switch. The solution(s) to this problem are explained in detail below.

Review the change control log. Find out if there are any switches recently installed, switches with configuration changes. Make sure that the configuration of the newly installed switch is correct.

Use the Simple Network Management Protocol (SNMP) tool to compare the configurations of all switches. Search for any newly created trunk port.
