Cisco 12000 Series Internet Router Parity Error Fault Tree

Document ID: 29320

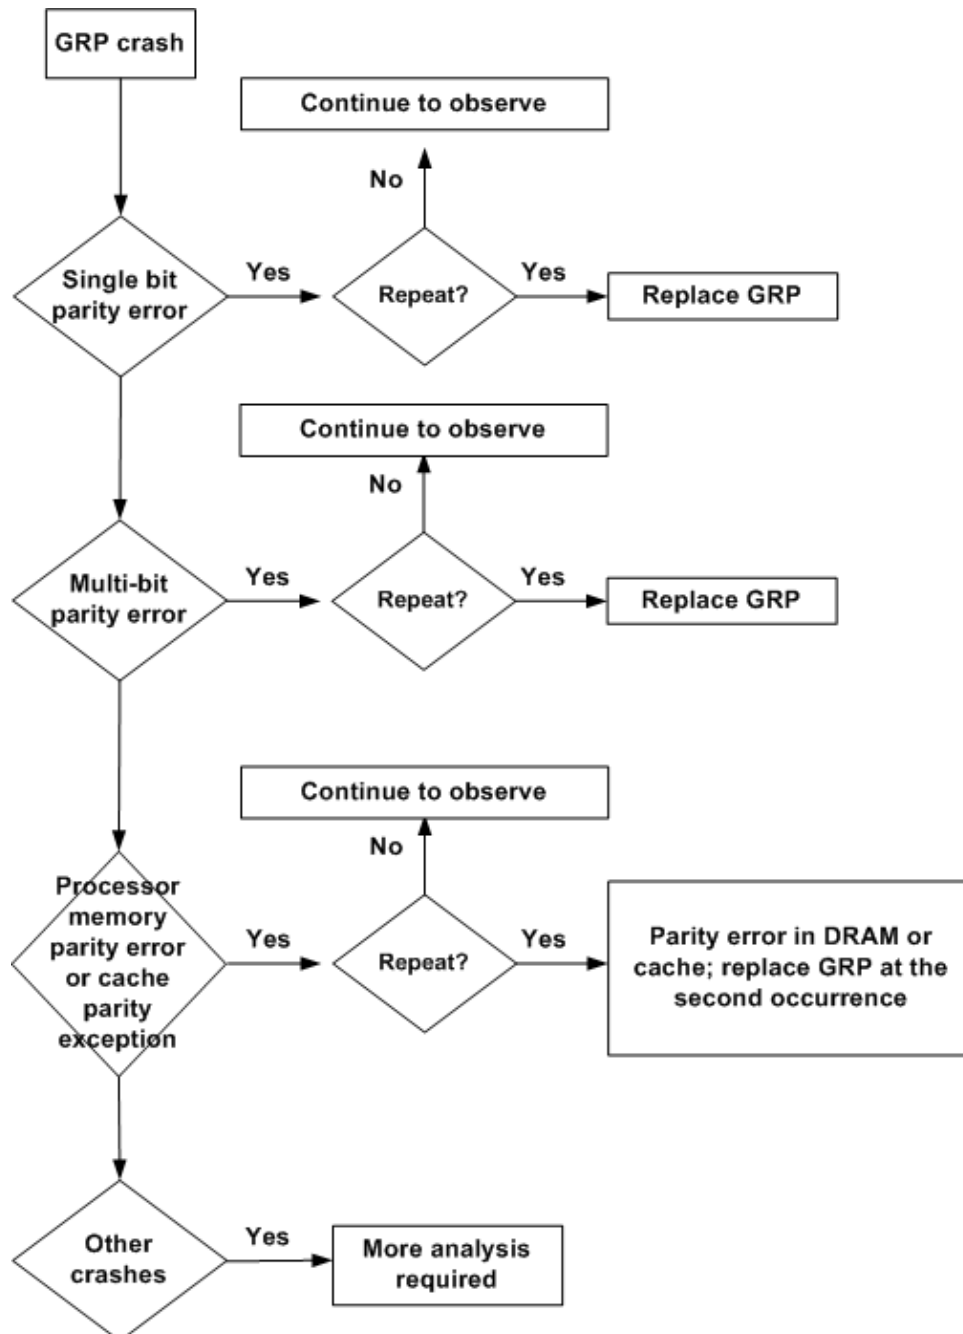
Gigabit Route Processor (GRP) Parity Error Fault Tree Analysis

The flowchart below helps you determine which component of the Cisco 12000 Series Internet Router is responsible for parity/Error Code Correction (ECC) error messages on the Gigabit Route Processor (GRP).

Note: Capture and record the **show tech-support** output and console logs, and collect all crashinfo files during parity/ECC error events.

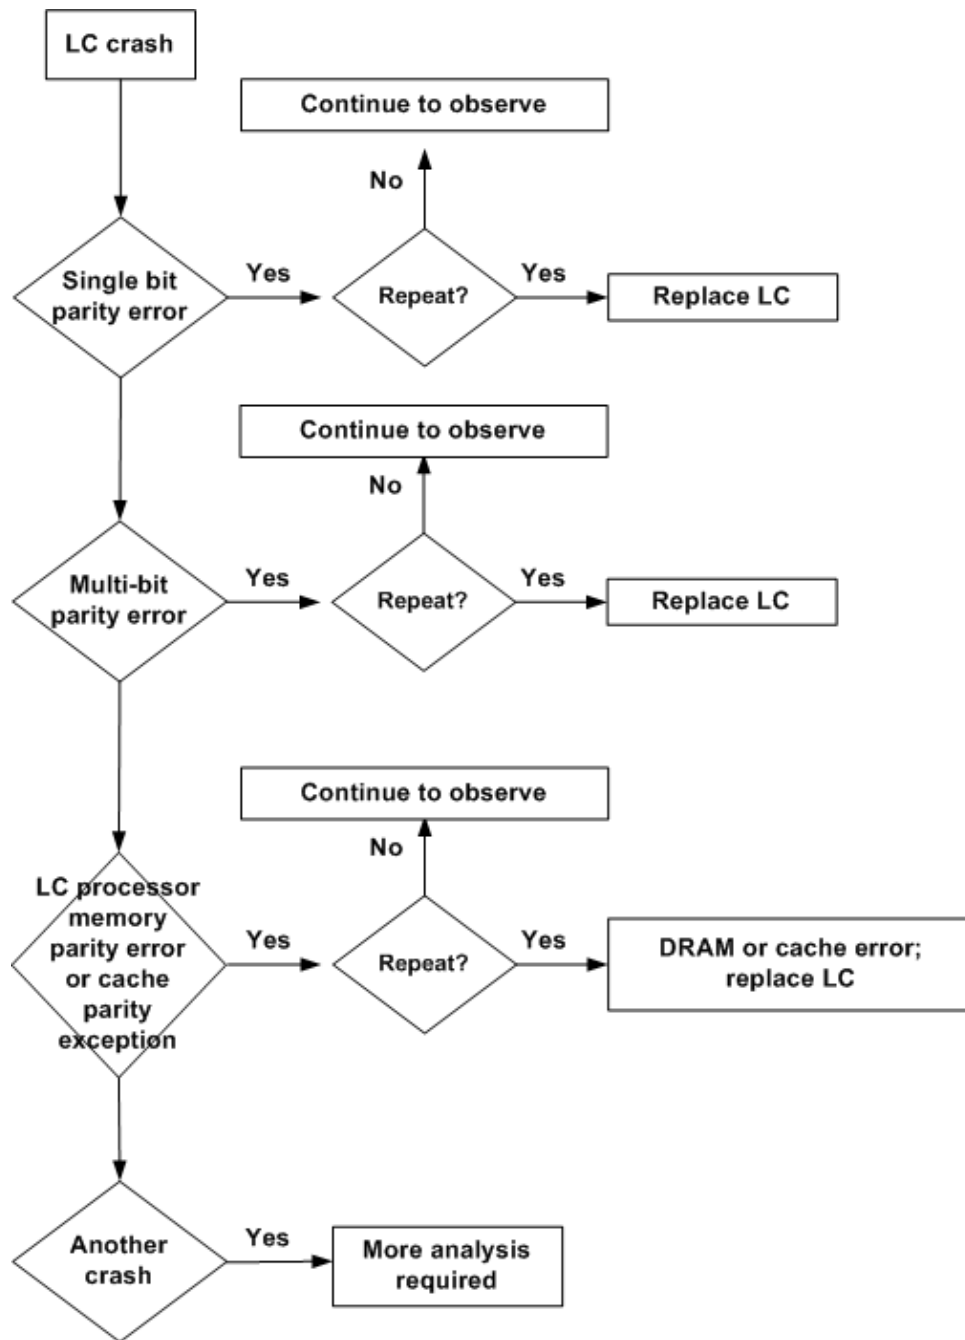
Line Card Parity Error Fault Tree Analysis

The flowchart below helps you determine which component of a Cisco 12000 Series Internet Router line card is responsible for parity/Error Code Correction (ECC) error messages:

Note: Whenever a line card experiences a parity/ECC error event, collect as much information as possible (see Troubleshooting Line Card Crashes on the Cisco 12000 Series Internet Router for details).
