CRS Installation Fails Due to the Wrong License File Suffix

Document ID: 49774

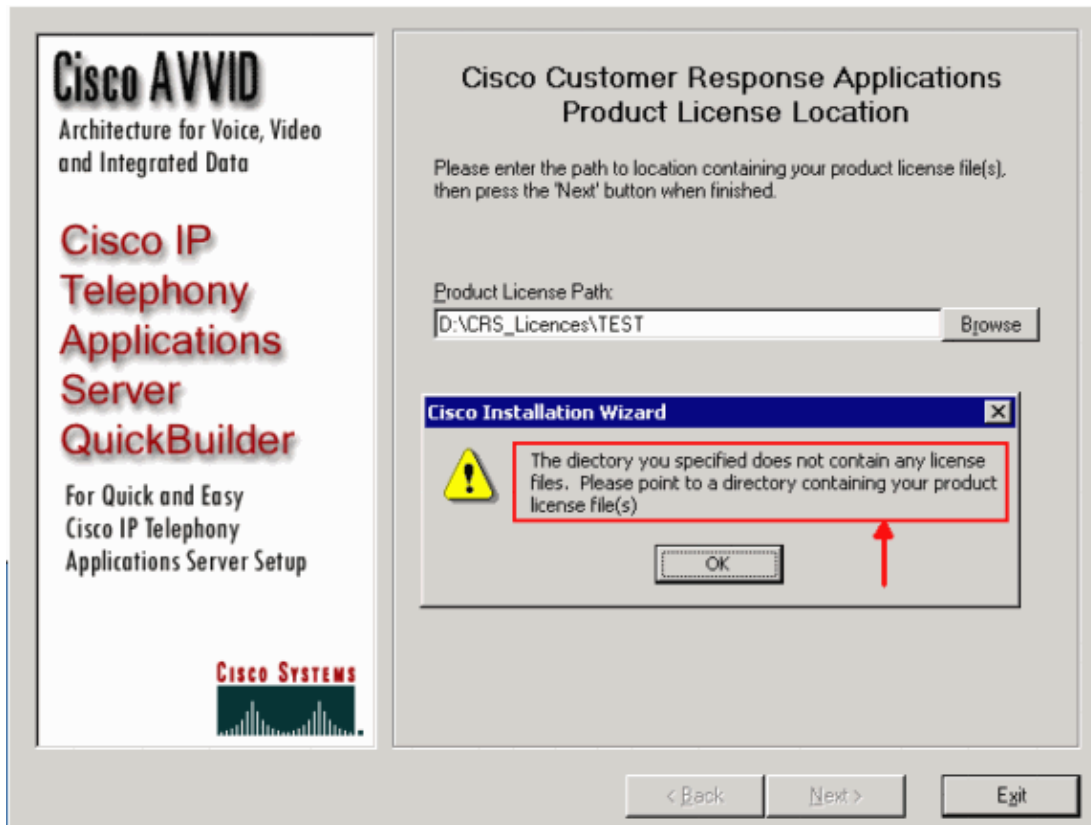
This error message appears when you install Cisco CRS:

```
The directory you specified does not contain any license files. Please
point to a directory containing your product license file(s).
```

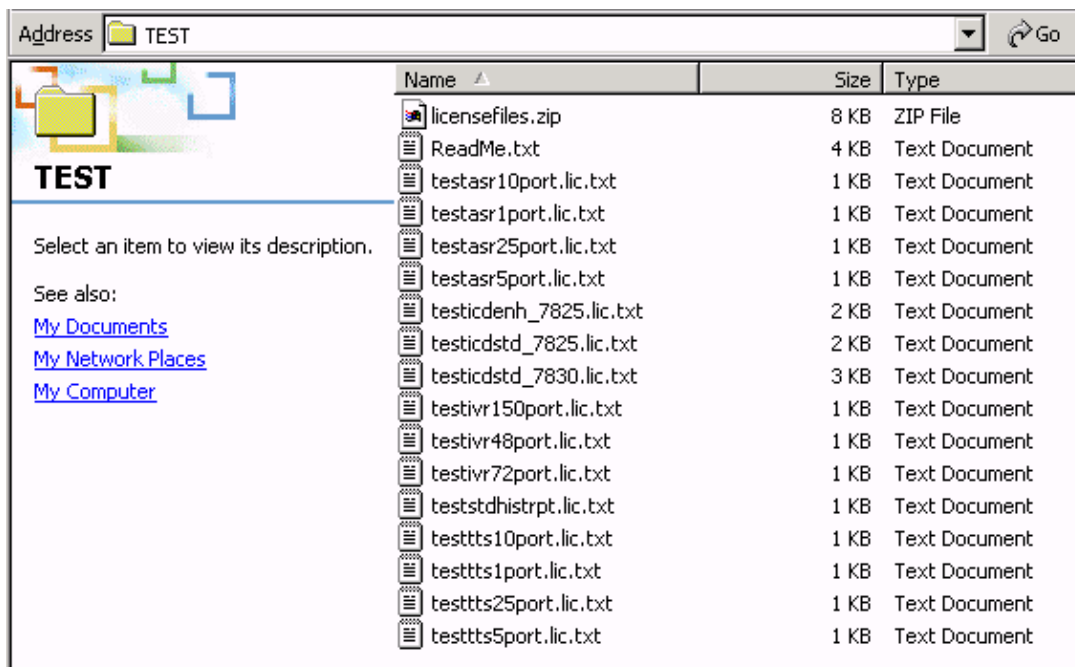
The root of the problem is the name of the license file. All the license files end with `.txt` instead of `.lic`, as shown here. One possible reason is that when you run Notepad in order to view the license file, it is saved as a text file in error.

The license file should end with **.lic**. Rename all license files involved in order to solve the problem.
