# ICM Drops Translation Route to IP IVR Calls

Document ID: 50582

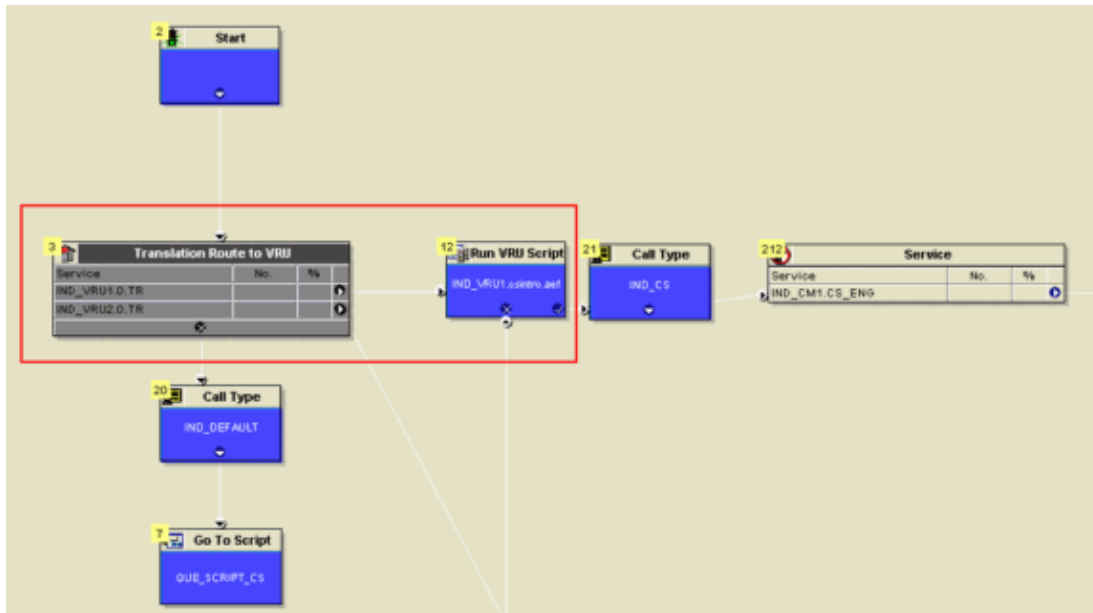
The ICM route point is associated with an ICM script which does a Translation Route to a VRU node to trigger a script on the IP IVR, as shown in below. This Translation Route VRU node fails.

When testing this specific ICM script through CallTracer, it completes correctly. However, when the incoming call hits the route point in the production environment, it fails with the following sequence:

1. Experiencing a short bit of silence.
2. A fast busy.

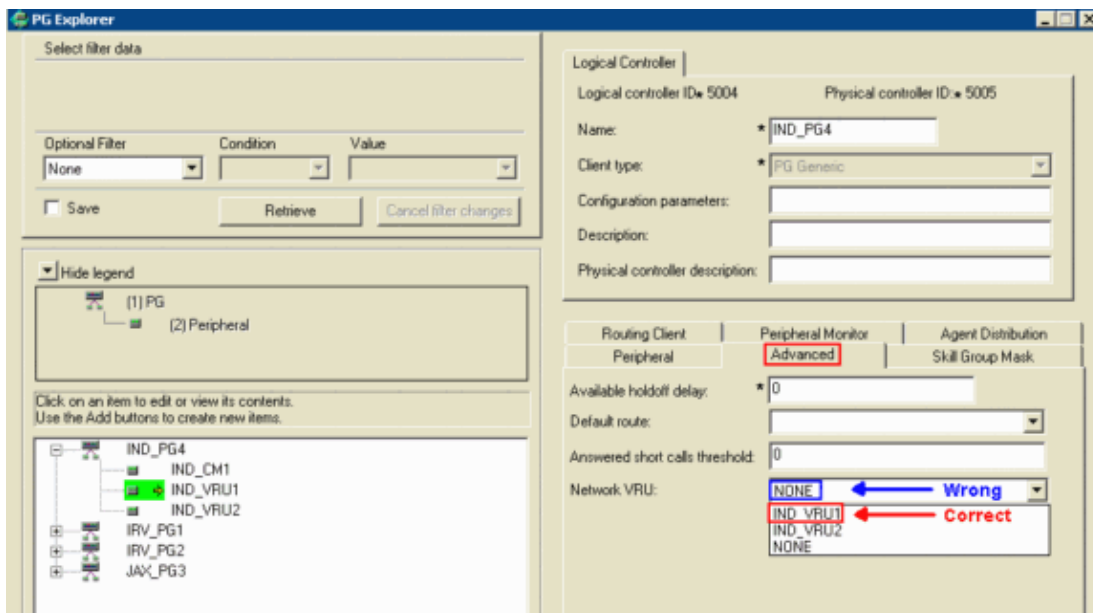
This is a configuration issue. View the rtr log file on the Router using the Dumplog utility, the following message appears:

```
15:20:51 ra-rtr Trace: TranRouteToVRU failed. Unable to map route 5009 to a network VRU
```

Verify the specific route, it is associated with a specific IP IVR. Check the configuration in PG Explorer, the **Network VRU** name is set to **NONE** instead of the name of this specific IP IVR under **Advanced**, as shown below. Select the right Network VRU name resolves this issue.
