Troubleshooting Unrecognized Voice Interface Cards on Cisco 1750, 1751, and 1760 Routers

Document ID: 5711

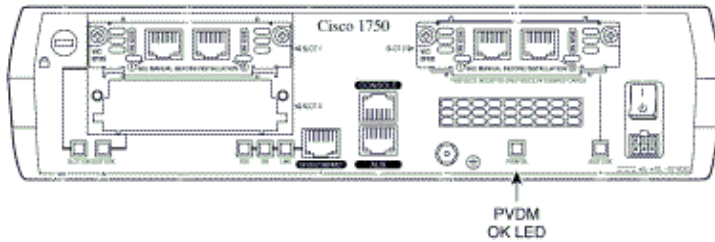
4. If the router does not recognize the VIC, verify that the PVDM OK LED is lit.

The PVDM OK LED indicates that a PVDM is correctly inserted in a PVDM card slot.

On the 175x routers, the PVDM OK LED is on the rear panel, as this diagram shows:

5. If the PVDM OK LED is not lit, verify that a PVDM is installed in at least one PVDM slot of the 175x or 1760 motherboard.

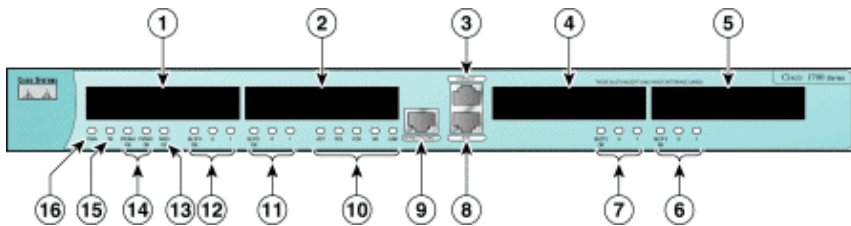
The Cisco 1760 has two PVDM OK LEDs, 0 and 1. There is one for each PVDM card slot. These LEDs are on the front panel. The number 14 indicates them in this diagram:
