# Installation of ICM 4.6.2 SR 1 Fails

Document ID: 60419

This document describes one reason why the installation of Cisco Intelligent Contact Management (ICM) Service Release (SR) 1 fails and provides a solution in a Cisco ICM Enterprise Edition environment.

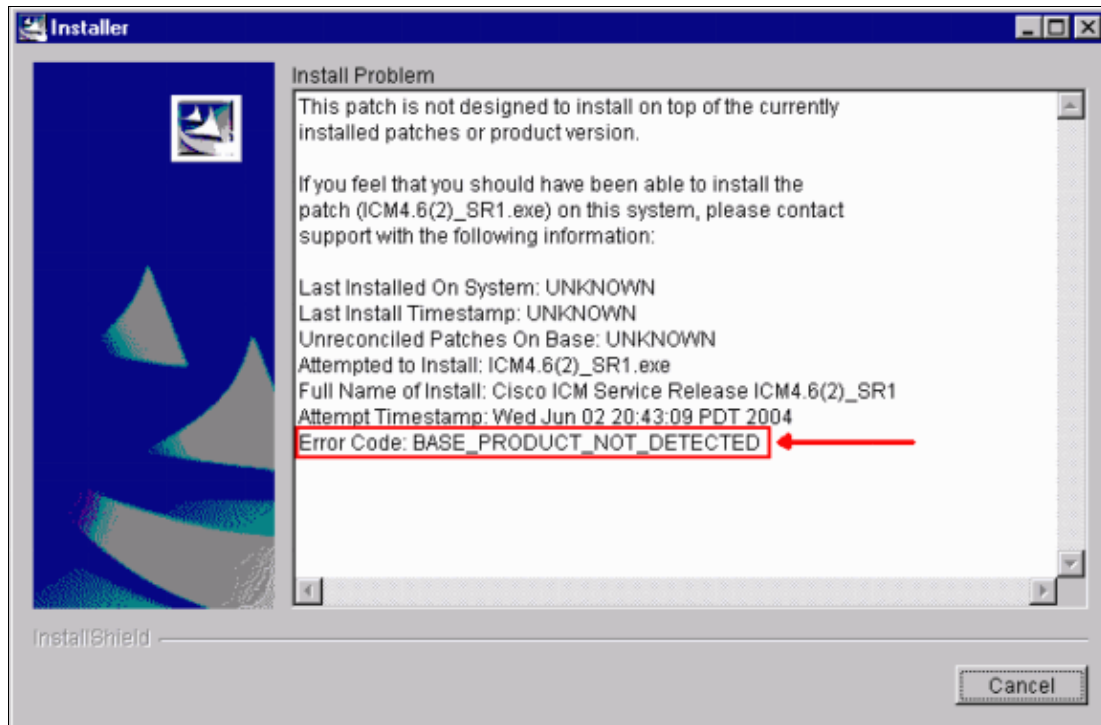
**Figure 1: Installer**

When you install ICM 4.6.2 SR1, the **Error Code: BASE\_PRODUCT\_NOT\_DETECTED** appears, as Figure 1 shows.

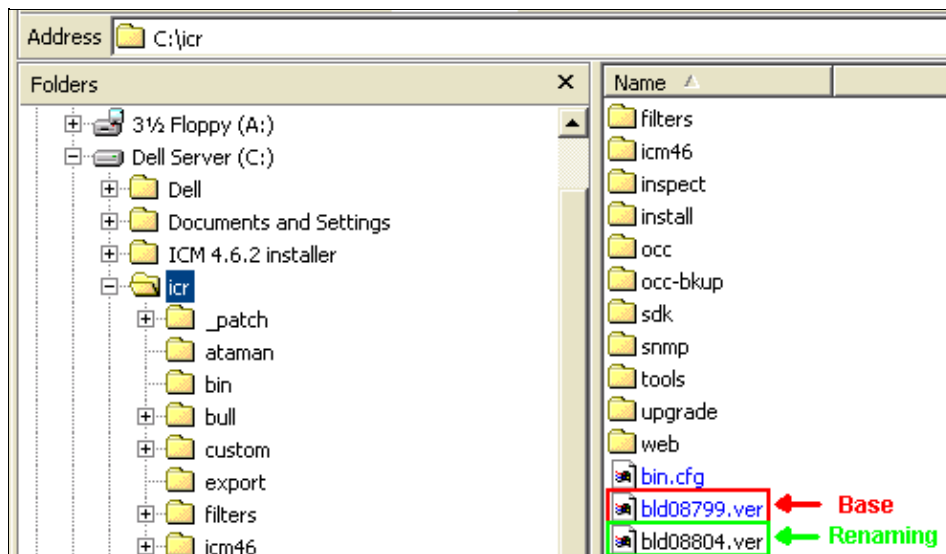
Figure 2: bld08799.ver

During the installation of ICM 4.6.2 SR1, the installer checks the c:\icr directory to verify the base software. For ICM 4.6.2 SR1, the base software is bld08799.ver, as Figure 2 shows.

If this file is not there, or if there are additional .ver files, the **Error Code: BASE\_PRODUCT\_NOT\_DETECTED** occurs. In multi-version scenarios, rename the additional .ver files to \* .old and make sure you rename the bld08799.ver file.

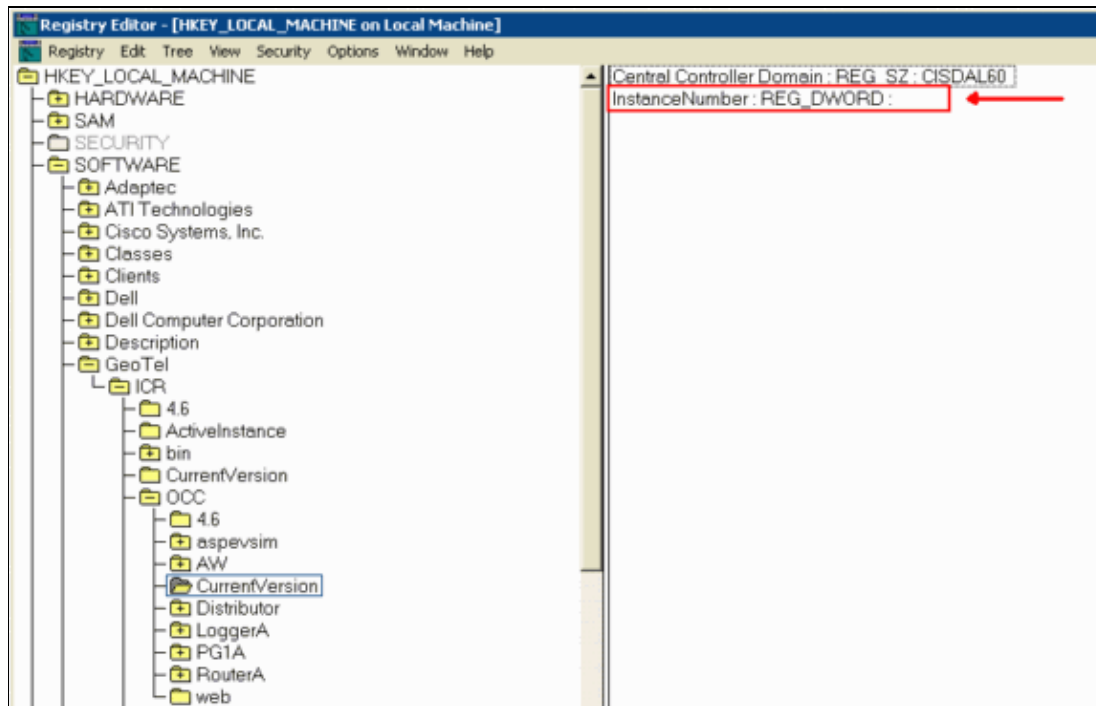
Figure 3: Registry Editor

Next, the installer checks the InstanceNumber key in the registry, as Figure 3 shows. If a value is missing, the installation of ICM 4.6.2 SR1 fails.

Set the InstanceNumber value to **0x0** in order to fix this problem.
