Troubleshoot Analog FXO GroundStart Outbound Call Failures

Document ID: 61947

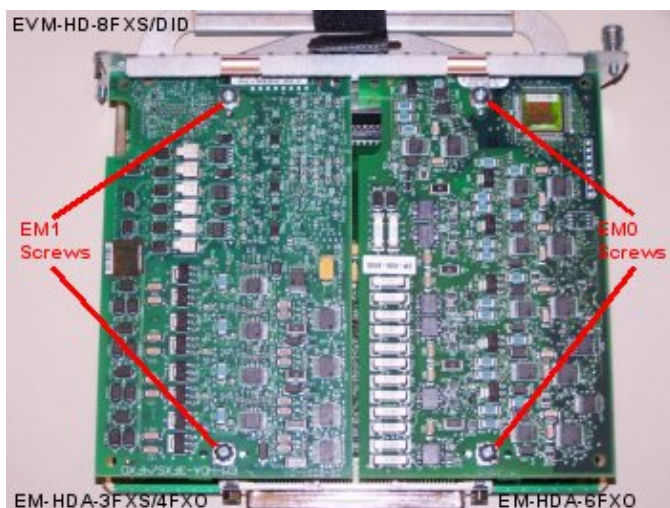
EVM-HD-8FXS/DID

1. As discussed earlier in Step 3 of the Troubleshooting Steps for GS Call Failures section, proper electrical grounding should always be observed. This is especially important on FXO Expansion Modules (EMs) which are installed onto base Network Modules (NMs). On the EVM-HD-8FXS/DID, these EMs are the EM-HDA-6FXO and EM-HDA-3FXS/4FXO; and on the NM-HDA-4FXS, it is the EM2-HDA-4FXO. The electrical connection between the EMs and the base NM constitute another degree of separation between chassis electrical ground and the NM, and care must be taken to ensure that the EMs are securely fastened to the NM for all electrical connectivity to be sound. For each EM, two mounting screws must be installed with 6.8 lbs-in (67.8 N-cm) of torque. **Failure to properly secure the EM hardware with both screws compromises product reliability; and, in the case of FXO ports, failure to properly tighten both mounting screws may cause FXO GroundStart outgoing call operation to fail outright.**

These pictures show the mounting screws which must be properly secured:
