# PG and CG Do Not Fail Over in the Duplexed Mode

Document ID: 64843

This document describes one reason why the Peripheral Gateway (PG) and CTI Gateway (CG) do not fail over in the duplexed mode in a Cisco Intelligent Contact Management (ICM) Enterprise Edition environment.

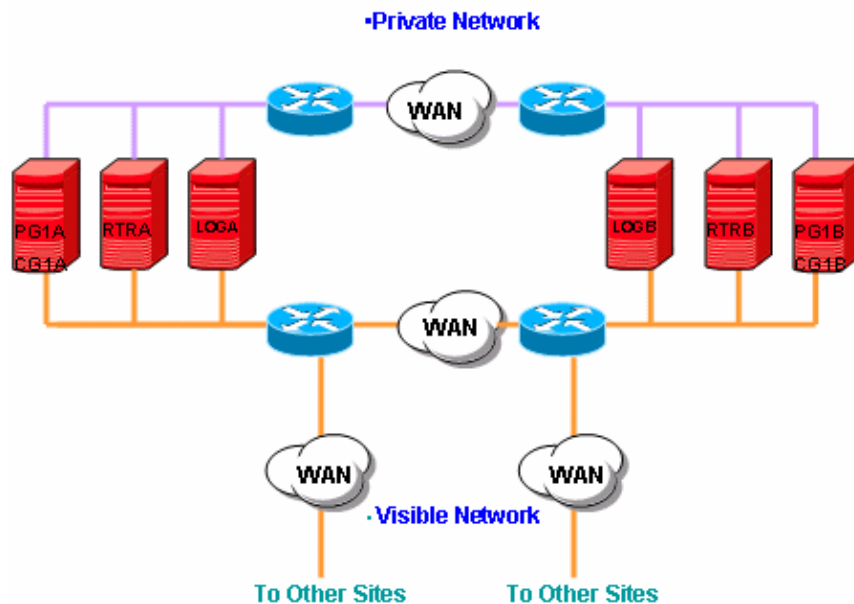
**Figure 1 A Sample ICM Duplexed Configuration**

In an IPCC Enterprise solution, the ICM topology is configured in a duplexed mode (see Figure 1). When one PG goes down, the other does not take over. For example, if PG1A is active, and PG1A stops, PG1B fails to take over.

In order for the PG to fail over successfully, you must ensure that the port numbers for MDSPort and StateXferPort on the PG and the corresponding CG are identical (see Figure 2). The port numbers are locally significant, but they need not be identical on A and B site. Cisco recommends you to retain the default values.

The problem is that the two port numbers do not match on the PG and CG. Run the PG and CG ICM setup in order to solve the problem.
