# CTI Data Fails to Reach Cisco Agent Desktop

Document ID: 66278

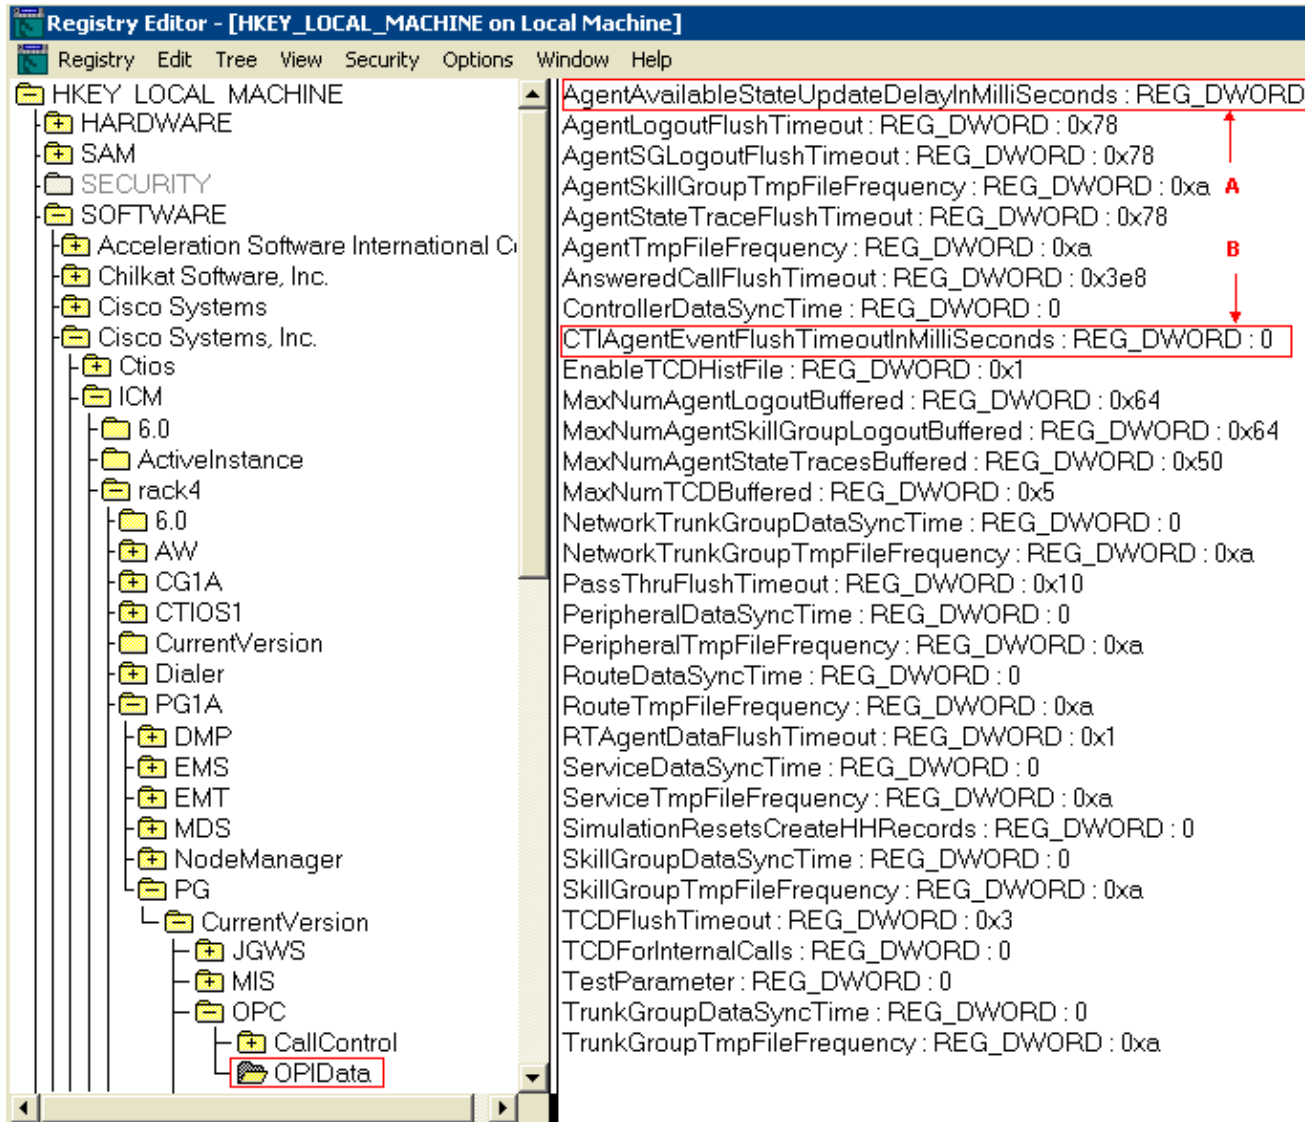
**Figure 2 Registry Key**

This problem occurs due to two registry settings on the peripheral gateway (PG).

3. Set the DWORD value of **AgentAvailableStateUpdateDelayInMilliseconds** to 0 (see arrow A in Figure 2).
4. Set the DWORD value of **CTIAgentEventFlushTimeoutInMilliseconds** to 0 (see arrow B in Figure 2).
5. Restart both PGs.
6. This message appears in the OPC log on the active PG side:
