# NTM Tx BData A Pkt Drp Errors

Document ID: 7007

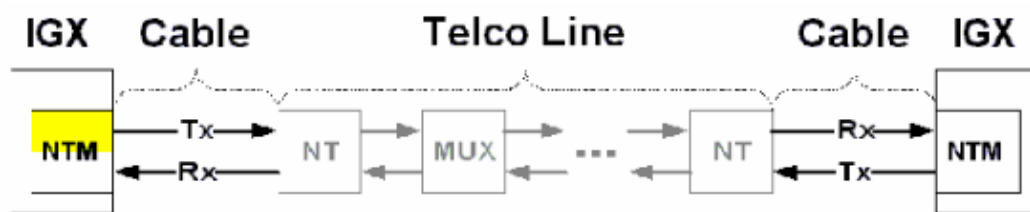
Pkt Drop

The likely location of equipment errors is highlighted in yellow.
