Why Are Some OSPF Routes in the Database but Not in the Routing Table?

Document ID: 7112

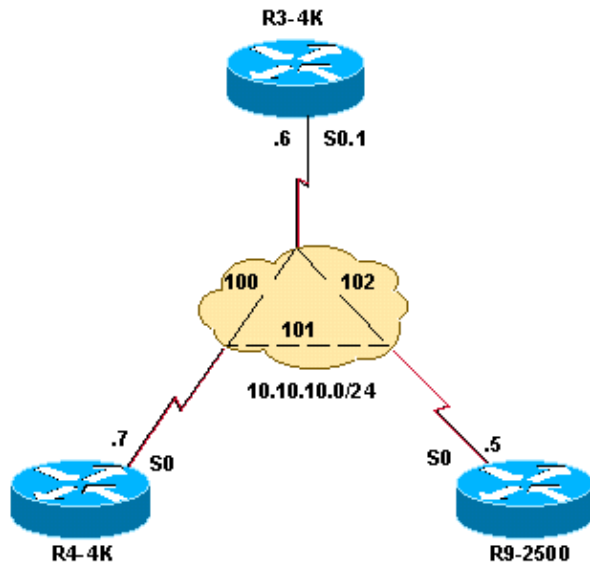
The broadcast model over Frame Relay works properly as long as the Frame Relay cloud is fully meshed. If any permanent virtual circuits (PVCs) are broken, it can create problems in the OSPF database, which in turn produces the Adv router not reachable message.

In this example, the PVC between R9-2500 and R4-4K is broken, and R9-2500 link to the designated router (DR) is broken. As a result, R9-2500 declares all LSAs from R3-4K (which is not a DR), as unreachable. As you can see, R9-2500 isn't generating a transit link for the serial interface attached to R3-4K; it is generating a stub link instead because as far as R9-2500 is concerned there is no DR on this link.

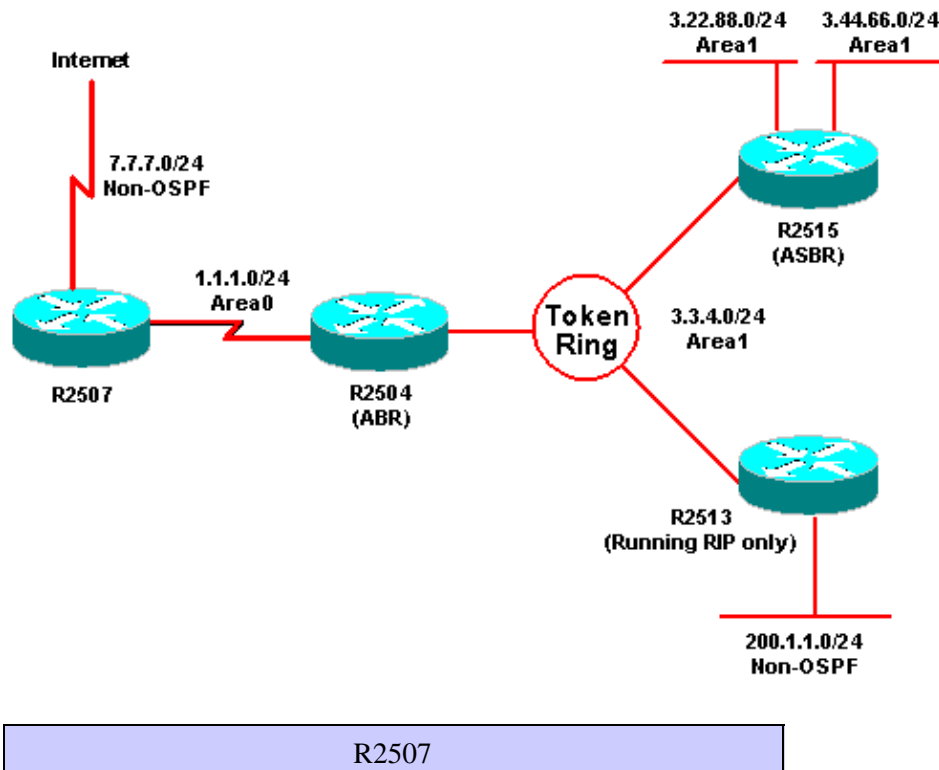
R2507 has 200.1.1.0/24 in its database but it hasn't installed it in the routing table because 3.3.4.4 is learned via an OSPF external route.

If the forwarding address is also known via an external route, OSPF doesn't install that route in the routing table. For more detailed information about this problem, see Common Routing Problem with OSPF Forwarding Address.
