Catalyst Express 500 Troubleshooting

Document ID: 71441

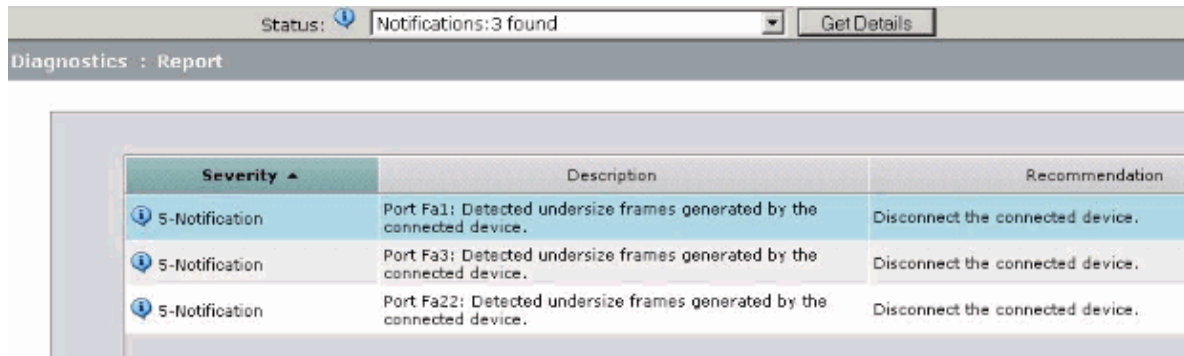
When you use dot1q on a trunk interface, valid dot1q encapsulated packets that are 61–64 bytes including the q-tag are counted as undersized frames by the CE500, even though these packets are forwarded correctly and are not dropped. This is cosmetic in nature, and there is no workaround for this issue, unless you remove dot1q, since the hardware ASIC cannot be changed by software.

Severity	Description	Recommendation
5-Notification	Port Fa1: Detected undersize frames generated by the connected device.	Disconnect the connected device.
5-Notification	Port Fa3: Detected undersize frames generated by the connected device.	Disconnect the connected device.
5-Notification	Port Fa22: Detected undersize frames generated by the connected device.	Disconnect the connected device.
