Intermittent Connectivity To MCS–78xx

Document ID: 8129

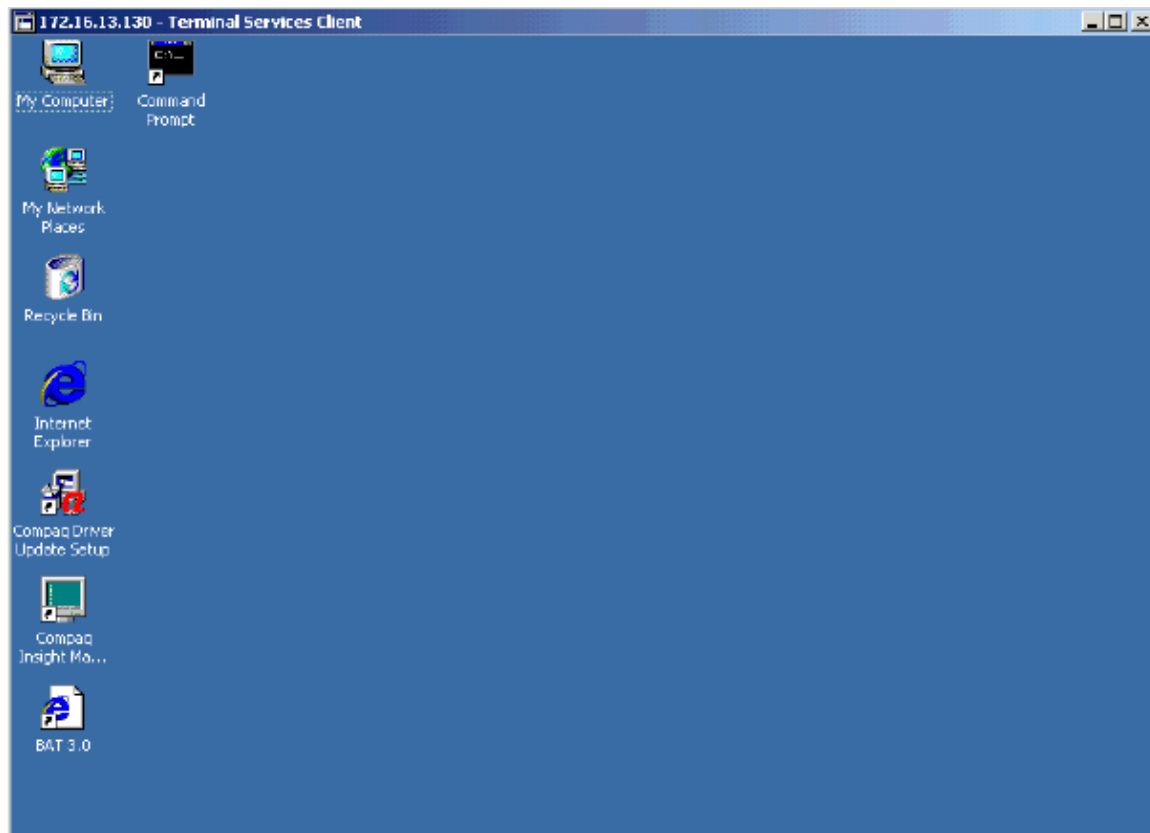
Intermittent Connectivity may be caused by outdated Ethernet network interface card (NIC) Drivers on your system.

Install the Compaq Driver Update. Double-click on the **Compaq Driver Update Setup** icon in order to install the drivers.
