Troubleshoot UCCX Finesse Barge-In Feature Issues

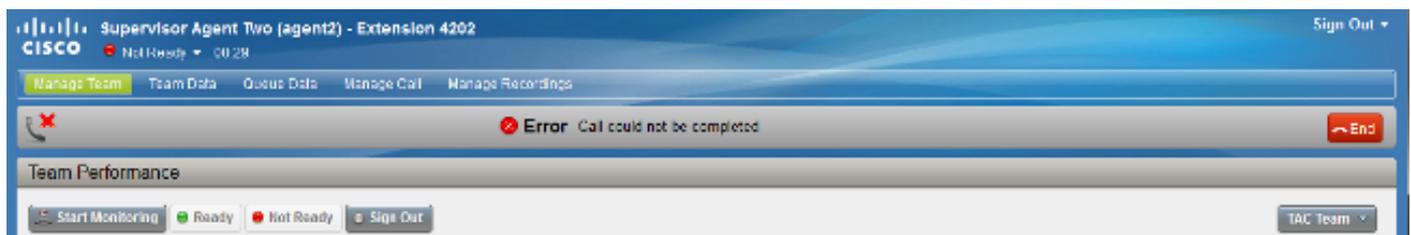
When a supervisor clicks **barge-in**, there is a delay of several seconds on the supervisor Finesse session, followed by this error message:

After the error appears, the consult leg of the barge-in operation might still appear as a regular inbound call that is not automatically answered. However, the error message does not clear from

the supervisor desktop.

This problem often arises when the agent device cannot immediately find a single match in the dial plan for the supervisor Directory Number (DN) that attempts to conference into the call. For example, if the supervisor DN is 4202, and longer potential matches exist in partitions that the agent DN searches (such as 42022 or 4202X), the agent phone does not attempt to connect to the supervisor phone until the interdigit time-out expires. By that time, the Finesse supervisor times-out due to the extended wait time for the call from the agent phone and displays the **Error – Call could not be completed** message.

In order to resolve this problem, ensure that the supervisor DNs trigger a unique match when the last digit of the supervisor DN is entered into the agent phone.
