Introduction

This document describes a problem that is encountered when a **Duplicate IP Address 0.0.0.0** error message is received by clients who run Microsoft Windows Vista and later versions. The methods that are used in order to resolve and troubleshoot the problem are also described.

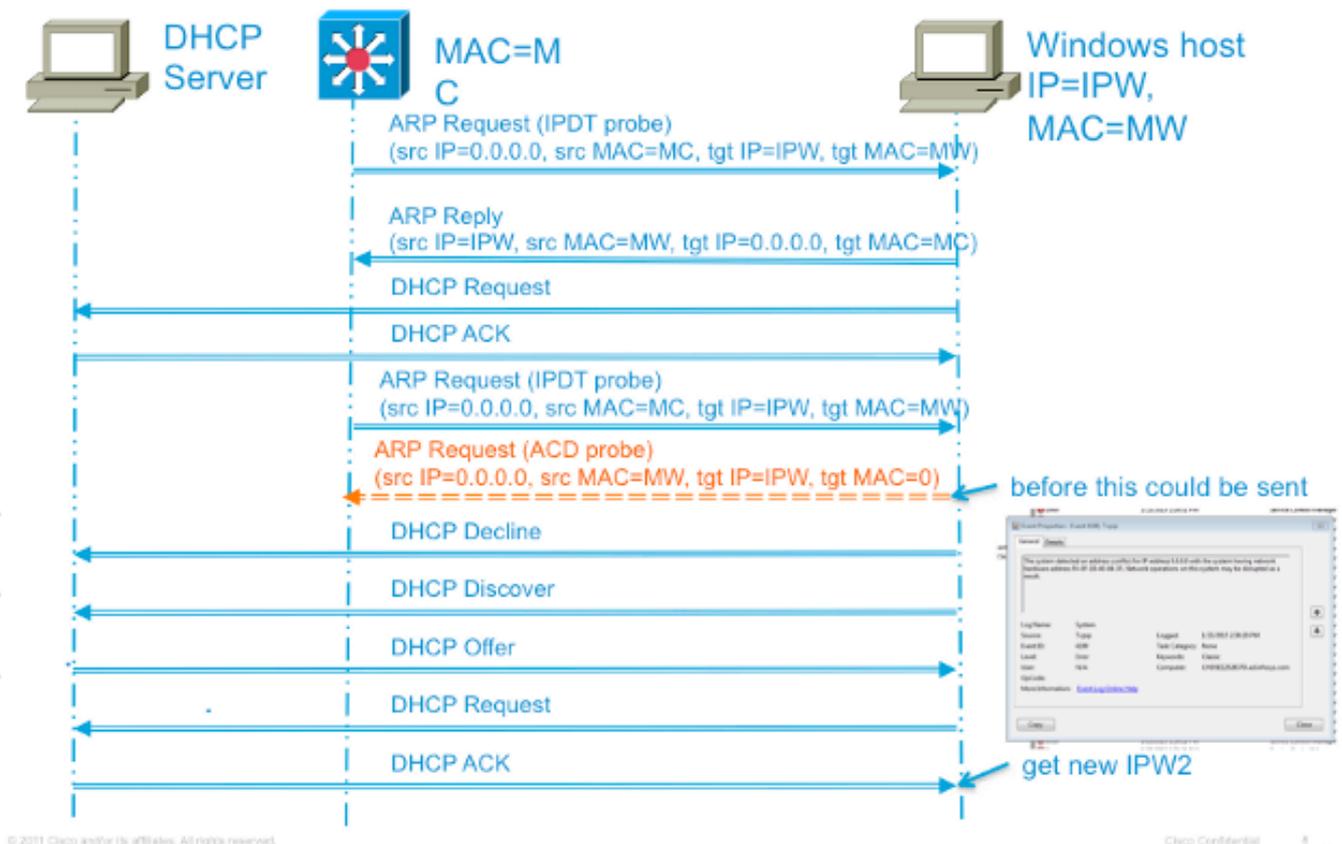
Failing Sequence Packet Flow

If the switch sends out an ARP Probe for the client while the Microsoft Windows PC is in its duplicate-address detection phase, then Microsoft Windows detects the probe as a duplicate IP address and presents a message that a duplicate IP address was found on the network for 0.0.0.0. The PC does not obtain an address, and the user must either manually release/renew the address, disconnect and reconnect to the network, or reboot the PC in order to gain network access.

Here is an example of the failed packet sequence:

- The most effective method that is used in order to prevent this issue is to configure the switch so that it sends a non-RFC compliant ARP Probe to source the probe from the Switch Virtual Interface (SVI) in the VLAN where the PC resides. If an SVI is configured for the VLAN and either of the two commands that follow are used, then the sender IP address in the IPDT probes will never be 0.0.0.0. Thus, it is certain that the duplicate IP address error will not occur.

- The primary non-SVI alternative that is used in order to work around the issue is to delay the probe from the switch so that Microsoft Windows has time to finish the duplicate IP address detection. This is effective only on access ports and link-up scenarios. Enter this command in order to delay the probe:

`ip device tracking probe delay 10`The RFC specifies a ten-second window for duplicate address detection, so if you delay the device-tracking probe, it resolves the issue in nearly all cases. In addition to probe-delay, the delay also resets when the switch detects a probe from the PC. For example, if the probe timer has counted down to five seconds and detects an ARP Probe from the PC, the timer resets back to ten seconds. This window can be further reduced if you enable DHCP snooping as well, as this similarly resets the timer. In rare circumstances, the PC sends an ARP Probe milliseconds before the switch sends its probe, which still triggers a duplicate address message to the end user. This command was introduced in Cisco IOS Version 15.0(1)SE on 2900, 3500, and 3700 Series Switch platforms, Version 15.0(2)SG on the 4500 Series Switch platform, and Version 12.2(33)SX17 on the 6500 Series Switch platform.
