低速タッチパネルの代替品の作成CS-T10-TS

[暫定的な回避策と解決策](#)

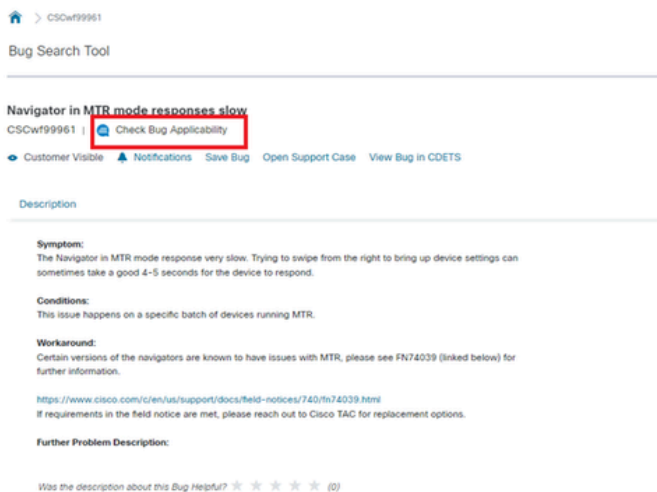
The screenshot shows the Cisco Bug Search Tool interface. At the top, there is a breadcrumb trail: Home > CSCwf99961. Below that is the title 'Bug Search Tool'. The main content area displays the bug title 'Navigator in MTR mode responses slow' and the ID 'CSCwf99961'. A red box highlights the 'Check Bug Applicability' button. Below the button are several links: 'Customer Visible', 'Notifications', 'Save Bug', 'Open Support Case', and 'View Bug in CDETS'. The 'Description' section follows, containing 'Symptom:', 'Conditions:', 'Workaround:', and 'Further Problem Description:' sections with detailed text.
