## Caveats for Cisco IOS Release 12.2(33)SRE

Caveats describe unexpected behavior in Cisco IOS software releases. Severity 1 caveats are the most serious caveats; severity 2 caveats are less serious. Severity 3 caveats are moderate caveats, and only select severity 3 caveats are included in this section.

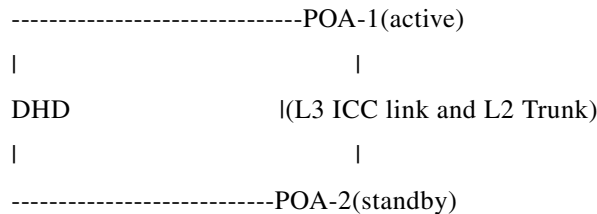
Topology:

Symptoms: In the following topology, the port-channel link on the standby PoA may forward packets unexpected to DHD. The issue is observed in both Cu's environment and the test lab:

In Cu's environment: When DHD sends an ARP request to ask for MAC of an HSRP virtual IP, it will receive the ARP reply from the standby PoA, causing MAC flapping on DHD. In the lab test environment: When you configure static ARP on PoAs to bind an IP address with a nonexistent MAC address, ping this IP, so it will do unicast flooding within VLAN. When you ping, POA-2(standby) also sends out the unicast packet to DHD via its port-channel link.

Conditions: This symptom occurs both on SRE2 and SRE3 with MLACP deployment.
