Release Notes for the Catalyst 3750 Metro Switch Cisco IOS Release 12.2(25)SEG and Later

Revised September 24

Cisco IOS Release 12.2(25)SEG and later run on the Catalyst 3750 Metro switch.

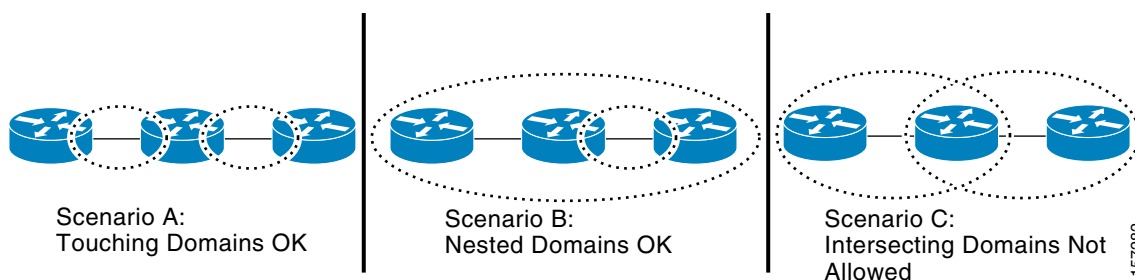
Figure 36-2 Allowed Domain Relationships

In Chapter 36, “Configuring Ethernet CFM and E-LMI,” Figure 36-2 originally showed incorrect examples for Scenario B and Scenario C. The illustration has been corrected as shown below:
