# Release Notes for Cisco Aironet 1200 Series Access Points Running Firmware Version 12.01T1

**January 20, 2003**

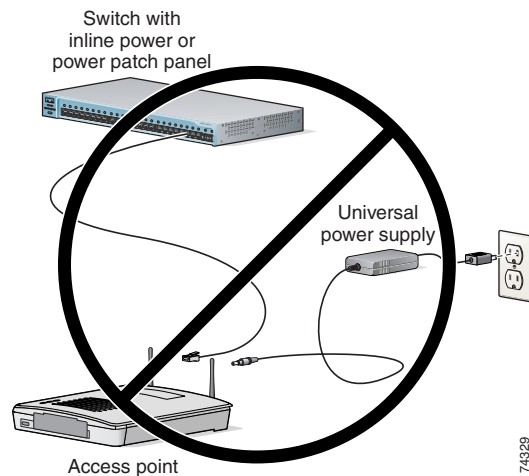
**Figure 1** Improper Power Configuration Using Two Power Sources

You cannot provide redundant power to the access point with both DC power to its power port and inline power from a patch panel or powered switch to the access point's Ethernet port. If you apply power to the access point from both sources, the switch or power patch panel might shut down the port to which the access point is connected. [Figure 1](#) shows the power configuration that can shut down the port on the patch panel or powered switch.
