Release Notes for Cisco Aironet 1200 Series Access Points Running VxWorks Firmware Version 12.05

September 27, 2004

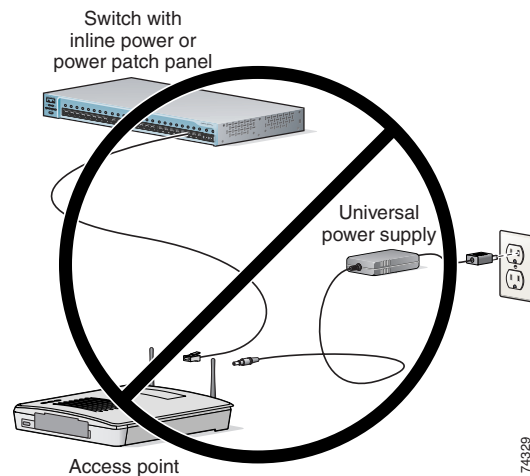
Figure 1 Improper Power Configuration Using Two Power Sources

You cannot provide redundant power to the access point with both DC power to its power port and inline power from a patch panel or powered switch to the access point's Ethernet port. If you apply power to the access point from both sources, the switch or power patch panel might shut down the port to which the access point is connected. [Figure 1](#) shows the power configuration that can shut down the port on the patch panel or powered switch.
