Release Notes for Cisco Aironet 1100 and 1200 Series Access Points for Cisco IOS Release 12.2(11)JA3

April 15, 2004

Cisco IOS Release 12.2(11)JA3 resolves caveats for 1100 and 1200 series access points but does not introduce new features. These release notes describe caveats for Cisco IOS Release 12.2(11)JA3 and features and enhancements introduced in Cisco IOS Release 12.2(11)JA.

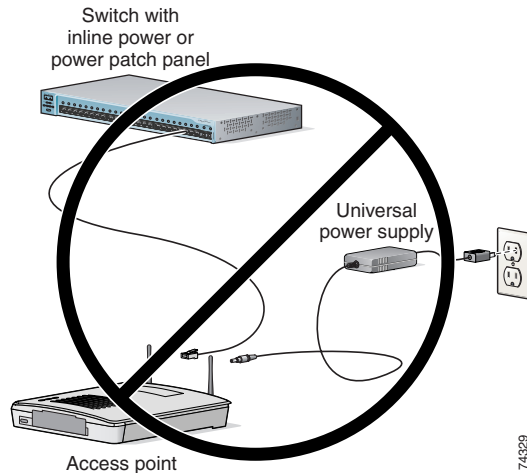
Figure 1 *Improper Power Configuration Using Two Power Sources*

You cannot provide redundant power to the access point with both DC power to its power port and inline power from a patch panel or powered switch to the access point's Ethernet port. If you apply power to the access point from both sources, the switch or power patch panel might shut down the port to which the access point is connected. [Figure 1](#) shows the power configuration that can shut down the port on the patch panel or powered switch.
