Release Notes for Cisco Aironet 350, 1100, and 1200 Series Access Points for Cisco IOS Release 12.2(15)XR2

September 20, 2004

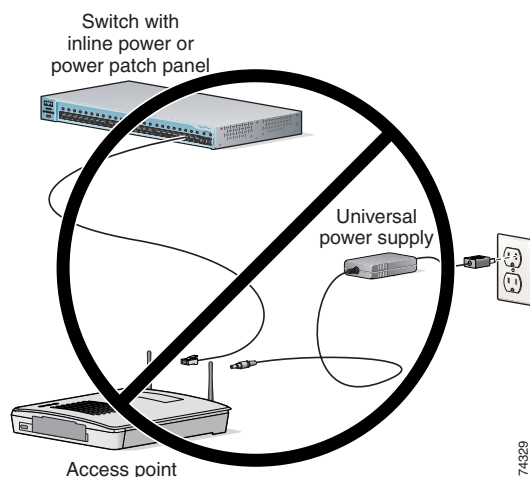
Figure 1 *Improper Power Configuration Using Two Power Sources*

You cannot provide redundant power to 1100 and 1200 series access points with both DC power to its power port and inline power from a patch panel or powered switch to the access point's Ethernet port. If you apply power to the access point from both sources, the switch or power patch panel might shut down the port to which the access point is connected. [Figure 1](#) shows the power configuration that can shut down the port on the patch panel or powered switch.
