Release Notes for Cisco Aironet 350, 1100, 1130AG, 1200, and 1230AG Series Access Points for Cisco IOS Release 12.3(2)JA2

February 3, 2005

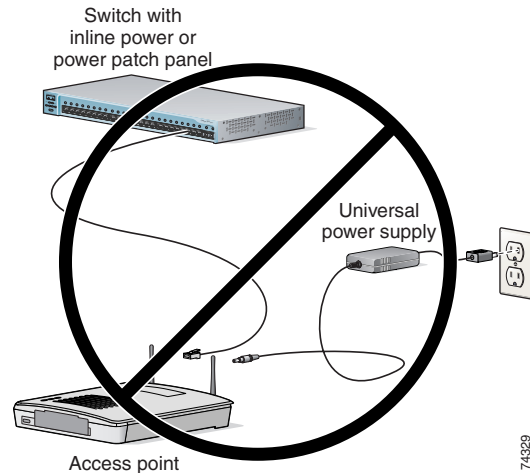
Figure 2 *Improper Power Configuration Using Two Power Sources*

You cannot provide redundant power to 1100, 1130, and 1200 series access points with both DC power to its power port and inline power from a patch panel or powered switch to the access point's Ethernet port. If you apply power to the access point from both sources, the switch or power patch panel might shut down the port to which the access point is connected. [Figure 2](#) shows the power configuration that can shut down the port on the patch panel or powered switch.
